# DAM EVALUATION REPORT

## Five Mile Dam (Hays County Park Lake Dam) TX04659

Five Mile Dam (also known as Hays County Park Lake Dam) was inspected by Freese and Nichols (FNI) on the morning of January 8, 2025. Based on visual inspection, the dam is in fair condition.

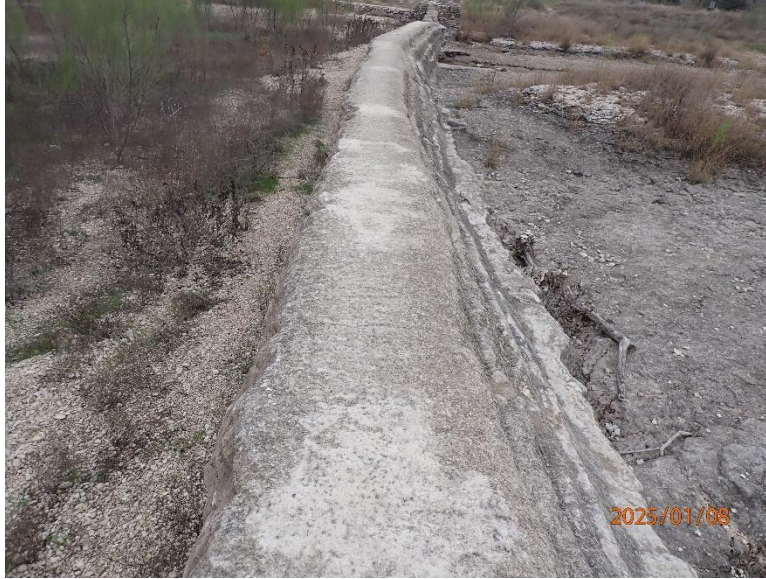
The dam consists of a gravity dam that is approximately 315 feet long with a maximum height of 8-feet and a crest width of approximately 3.5 feet. (Photo No. 1) The crest of the dam was found to be in fair condition.

- The crest has some minor erosion on the upstream side that has developed over time.
- There is minor cracking on the dam crest, but this does not currently present a dam safety issue.
- There were no signs of depressions, bulges, or misalignment noted on the crest of the dam.

*Photo No. 1: View of dam crest*

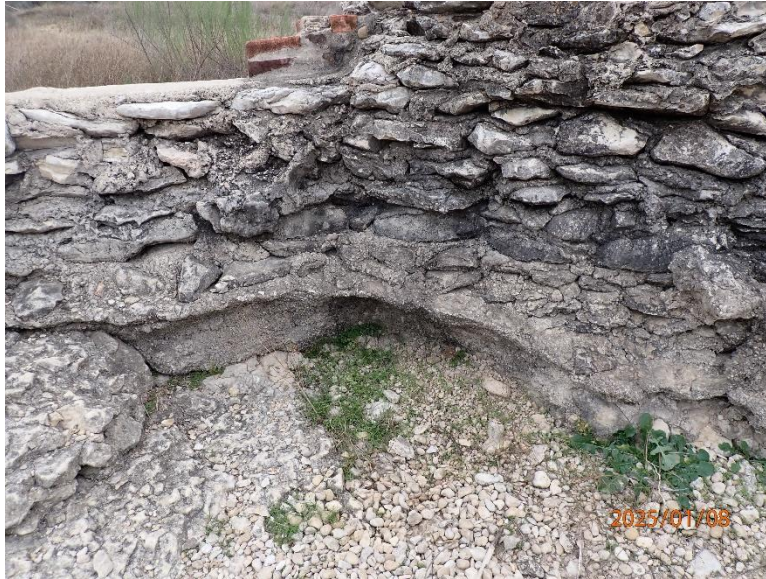
- There is scour erosion on the upstream side of the left abutment (Photo No. 2). This area does not require immediate repair but should be monitored for changes over time during regularly planned maintenance and inspections of the dam.
- The 2016 inspection noted minor seepage under the left abutment at the connection of the cylindrical gravity structure to the bank wall. No seepage was observed due to the lake being dry. The seepage observed in 2016 may be related to the scour erosion noted in this inspection.

*Photo No. 2: Scour erosion on upstream side of left abutment*

1. Monitor the small scour area on the upstream face near the left abutment for changes over time, or for evidence of seepage through the area.
2. Monitor the eroded section at the right abutment for changes over time.
3. Monitor the scour and voids on the downstream toe for changes over time.

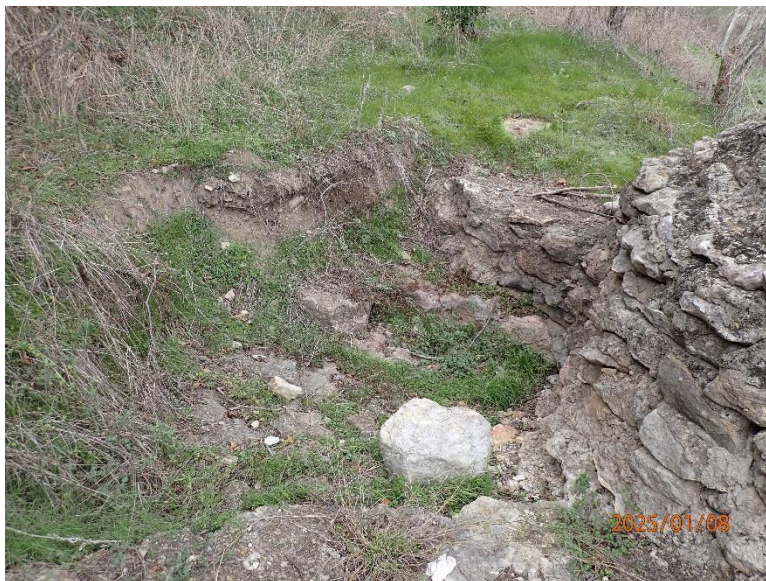
- There is an 8-foot-wide, 26-inch-tall, eroded section on the groin downstream at the right abutment (Photo No. 3). The size of the eroded area is similar to the 2016 inspection.

*Photo No. 3: Eroded section at the right abutment*

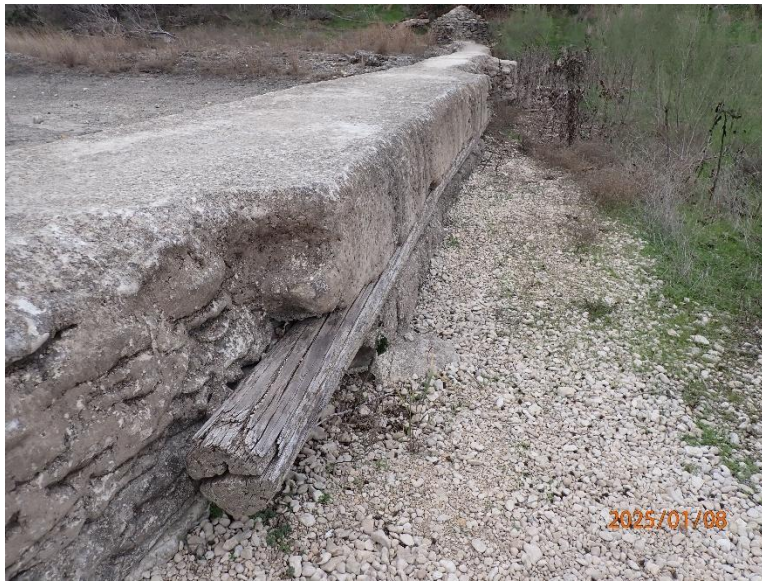
The upstream face of masonry is a vertical face wall. The 2016 report noted a sunken log in the upstream face of the dam (Photo No. 4). With the lake dry, the log appears to have been there since the dam was constructed. The upstream face of masonry is in fair condition.

*Photo No. 4: Log embedded on the upstream face*

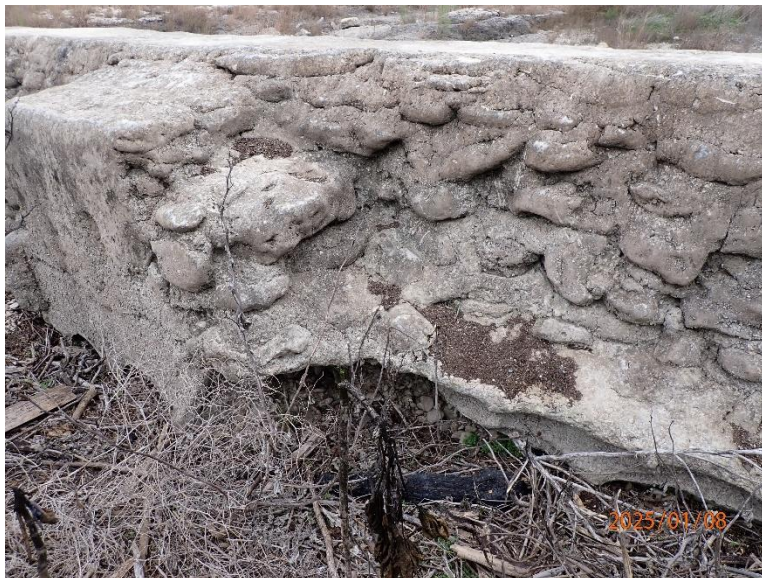
- There is some minor scour (Photo No. 5), approximately 1 foot deep, on the upstream toe of the dam on the right side of the decommissioned low flow outlet, which is typical for dams of this age.

*Photo No. 5: Minor scour on upstream toe*

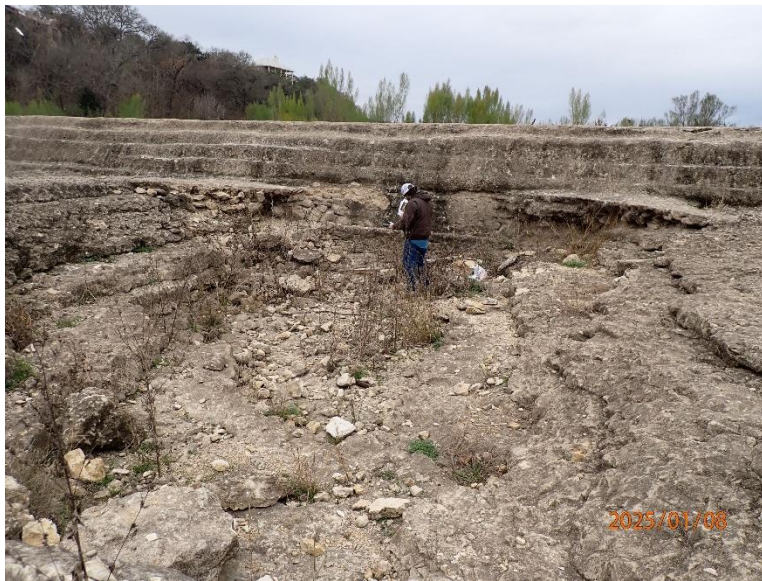
- There is a 22-foot-wide scour area approximately 5 to 6 feet below the downstream toe of the dam (Photo No. 6), near the left abutment. The amount of scour in this area appears similar to the 2016 inspection. Since the scour erosion does not appear to be changing significantly over that time, no issues with the stability and integrity of the dam are evident. This area should be monitored for changes over time during regularly-planned maintenance and inspections of the dam
- There is a 5-foot-wide section of the downstream face that was recently broken off (Photo No. 7). This section appears to be part of the overhang above the 22-foot-wide scour area.
- There are multiple spots with 2 to 3 feet deep voids on the right side of the scour area (Photo No. 8).

*Photo No. 6: 22-foot-wide scour on the downstream face*

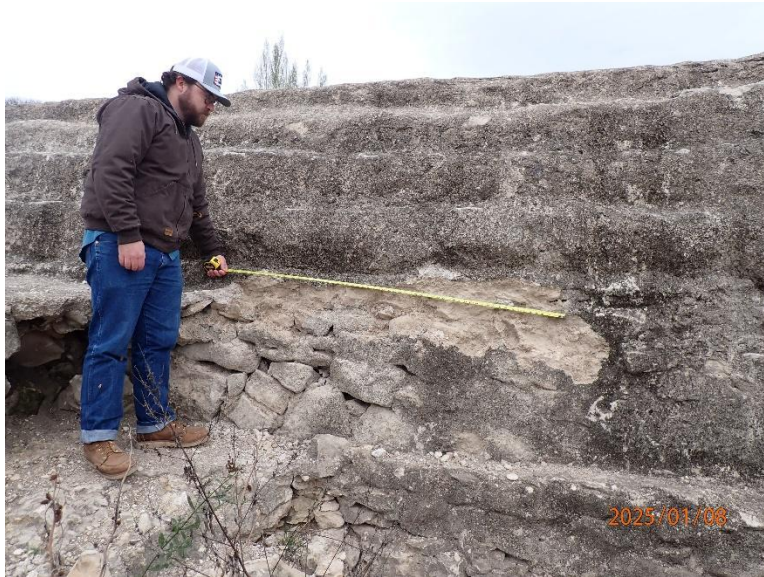
*Photo No. 7: 5-foot-wide broken off section on downstream face*

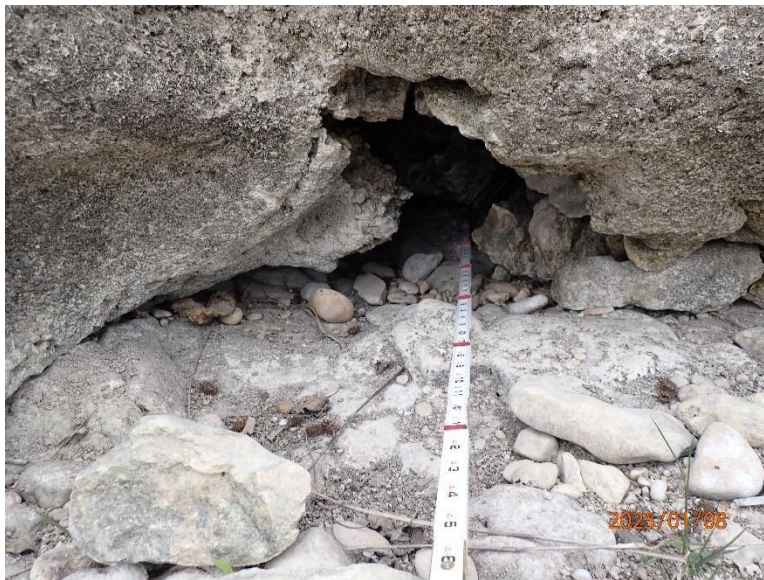
*Photo No. 8: 2' to 3' deep voids on downstream toe*

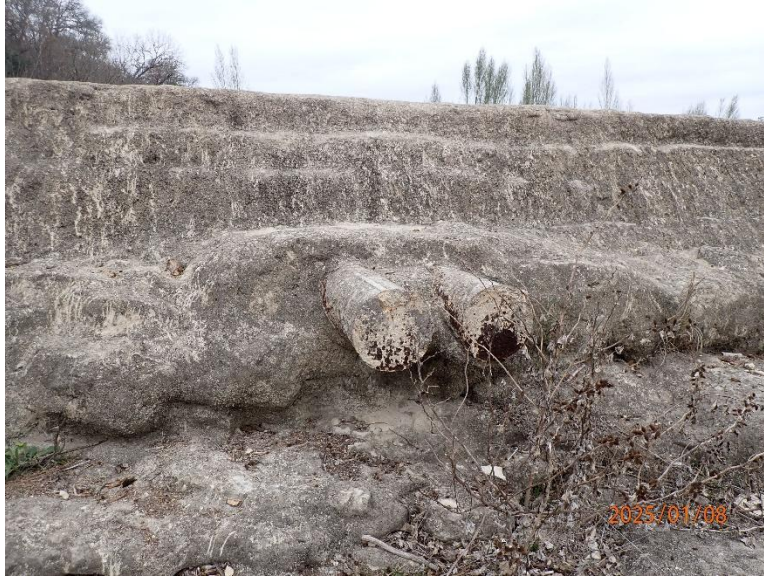
The dam functions as the service overflow spillway and allows regular flows to discharge over the dam. The originally designed service spillway consists of a decommissioned low flow outlet with two pipes. There are two outlet pipes that have been infilled with concrete and are no longer operational (Photo No. 9).

*Photo No. 9: Low flow outlet*

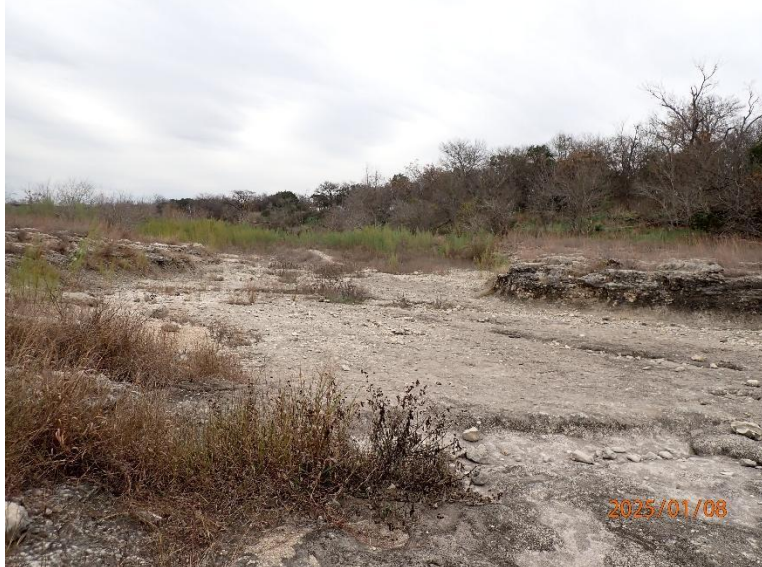
The downstream channel, as viewed from the dam, appears clear and able to convey flood flows away from the dam suitably (Photo No. 10). The downstream channel also appears to have been grouted approximately 300 ft immediately downstream of the dam.

*Photo No. 10: View of downstream channel*

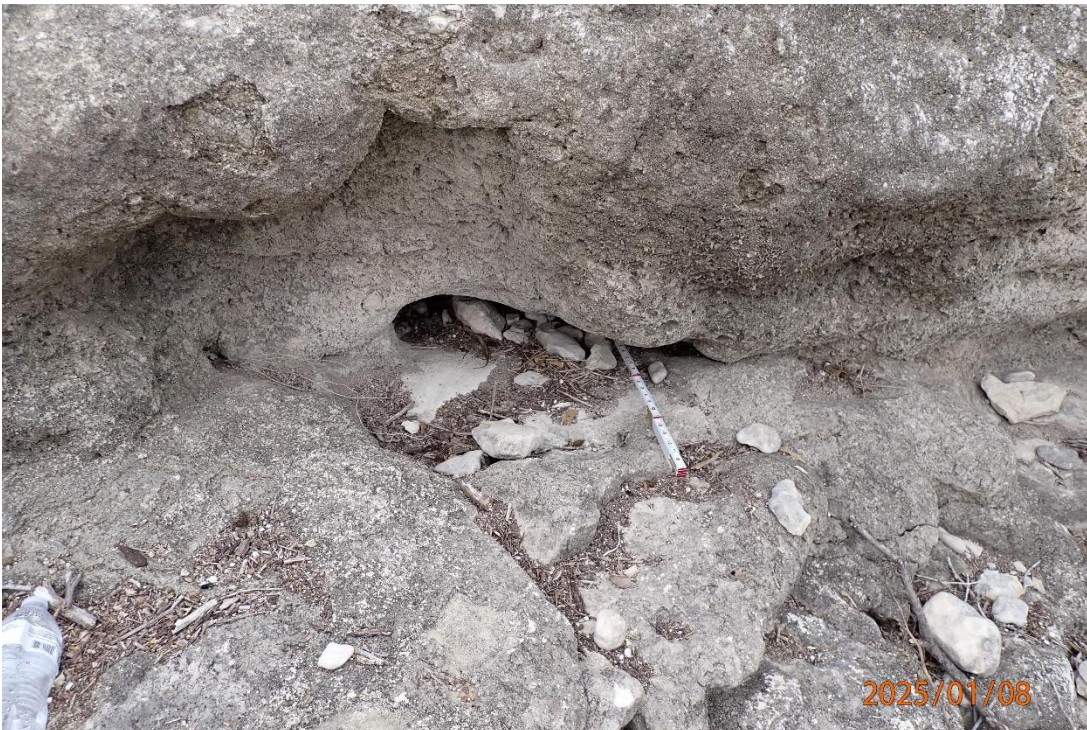
Photo No. 18: Void on downstream toe

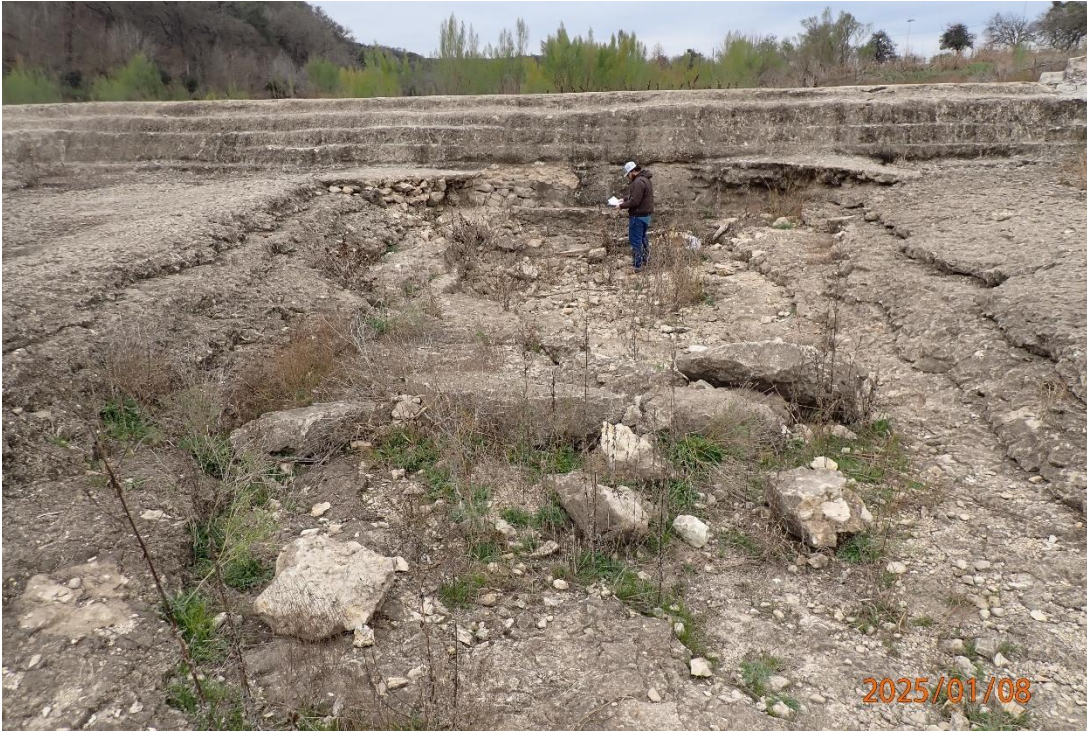
Photo No. 19: Scour on downstream toe

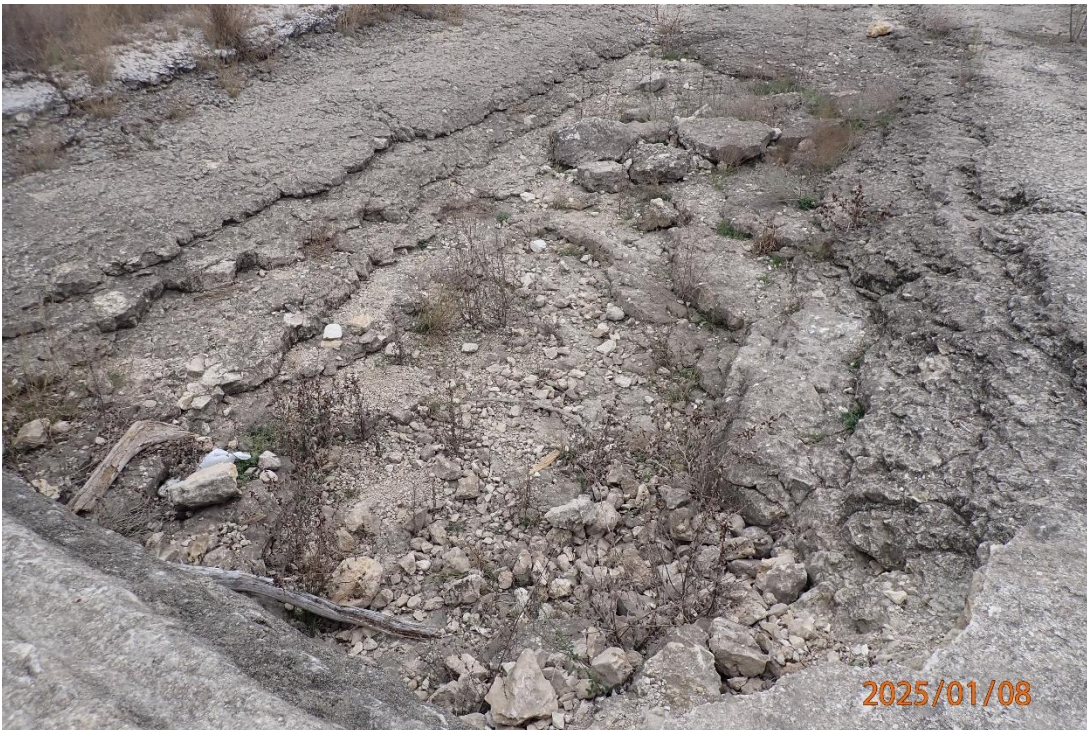
Photo No. 20: Looking downstream at scour hole

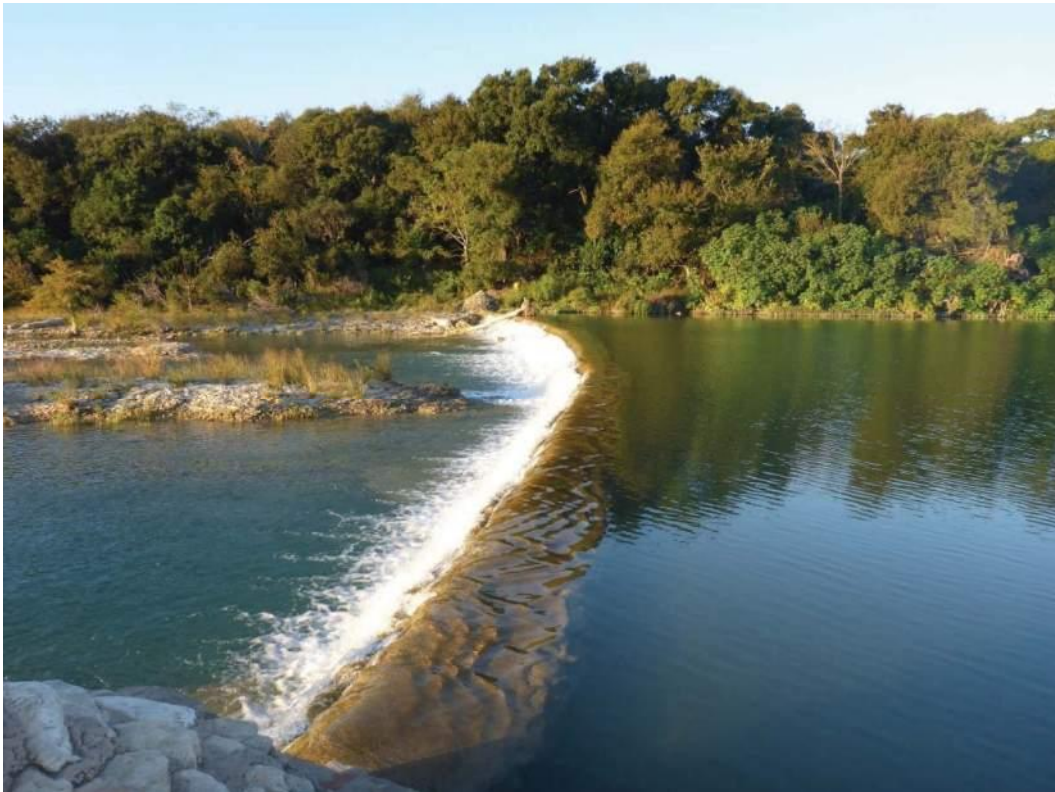
- The crest has some minor erosion on the upstream side that has developed over time (Photo 2, which is typical of a channel dam subjected to daily flows).
- There is a large diameter tree trunk that is lodged on the top of the crest (Photo 3).

Photo 2 – Crest of the Dam (Primary Overflow Section)

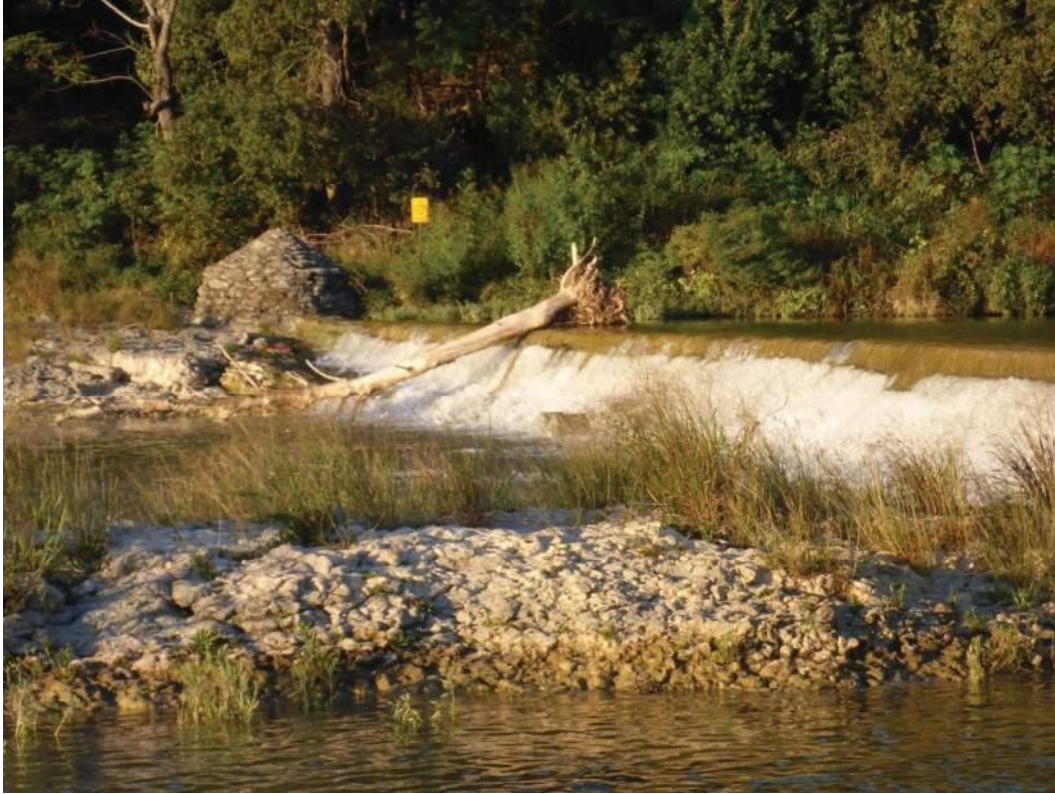
Photo 3 – Large Diameter Tree Debris

**Repair Items Ranked by Priority**Item 1: Monitor seepage and repair during time of low flowItem 2: Remove tree on dam crest

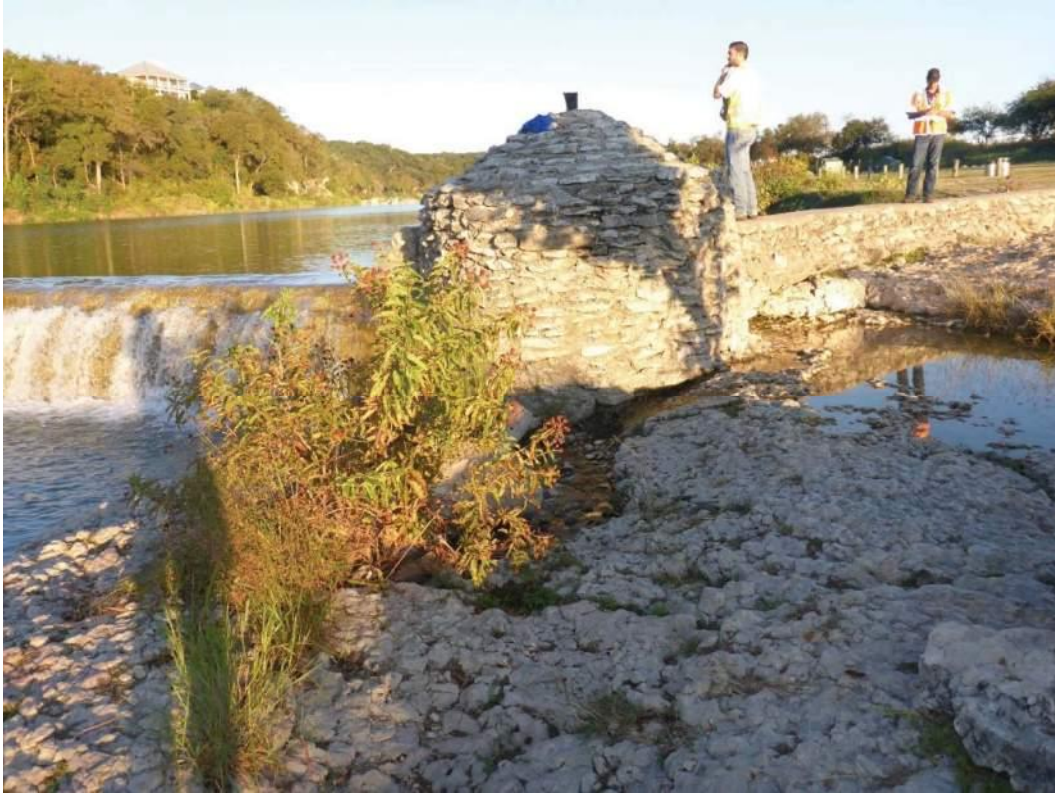
- There is a minor seep under the left abutment at the connection of the cylindrical gravity structure to the bank wall (Photo 5).
- There is some minor vegetation downstream of the left abutment (Photo 6).

Photo 5 – Seep at Left Abutment

**Seepage on Downstream Slope** Amount: ☐ Major ☐ Moderate ☒ Minor ☐ None Found  
Problems Noted: ☐ None ☐ Saturation Starts at \_\_\_\_% up Embankment ☐ Presence of Sediment in Flow  
☐ Cattails at Toe of Dam ☐ Surface Water at Toe of Dam ☐ Seepage Associated with Sloughing  
☐ Continuous Flow ☐ Sporadic Flow  
Comments: Occurs at connection of left abutment to the bank wall

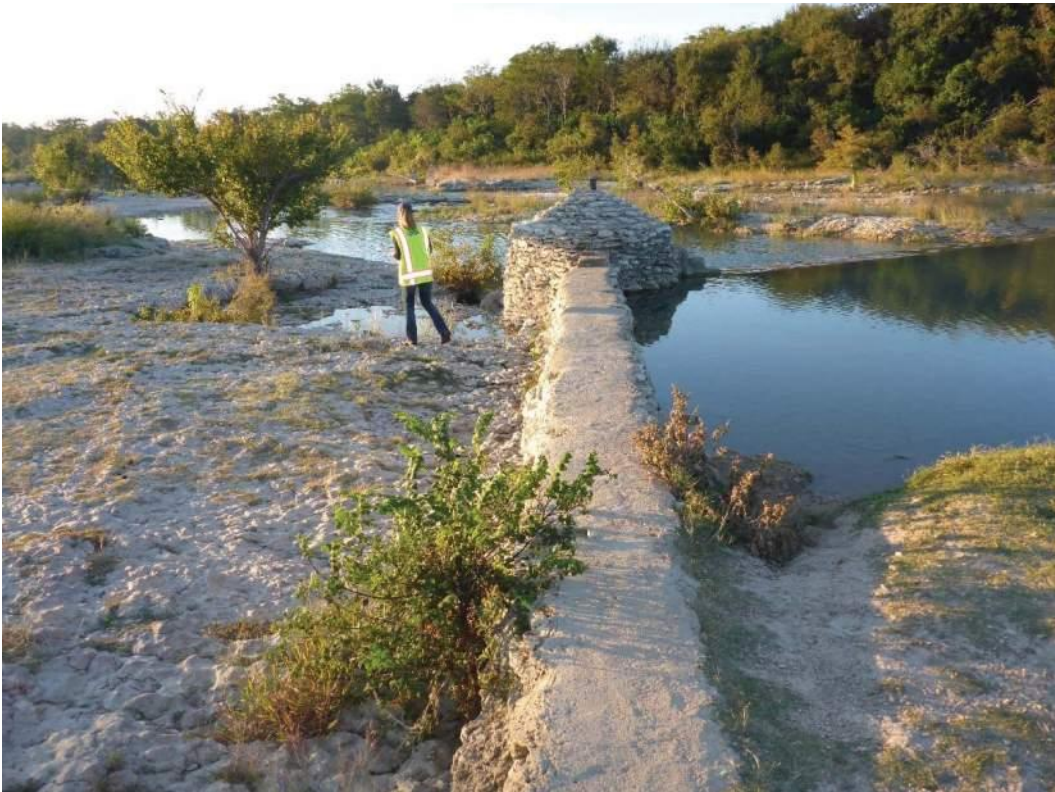
Photo 6 – Vegetation Downstream of Left Abutment

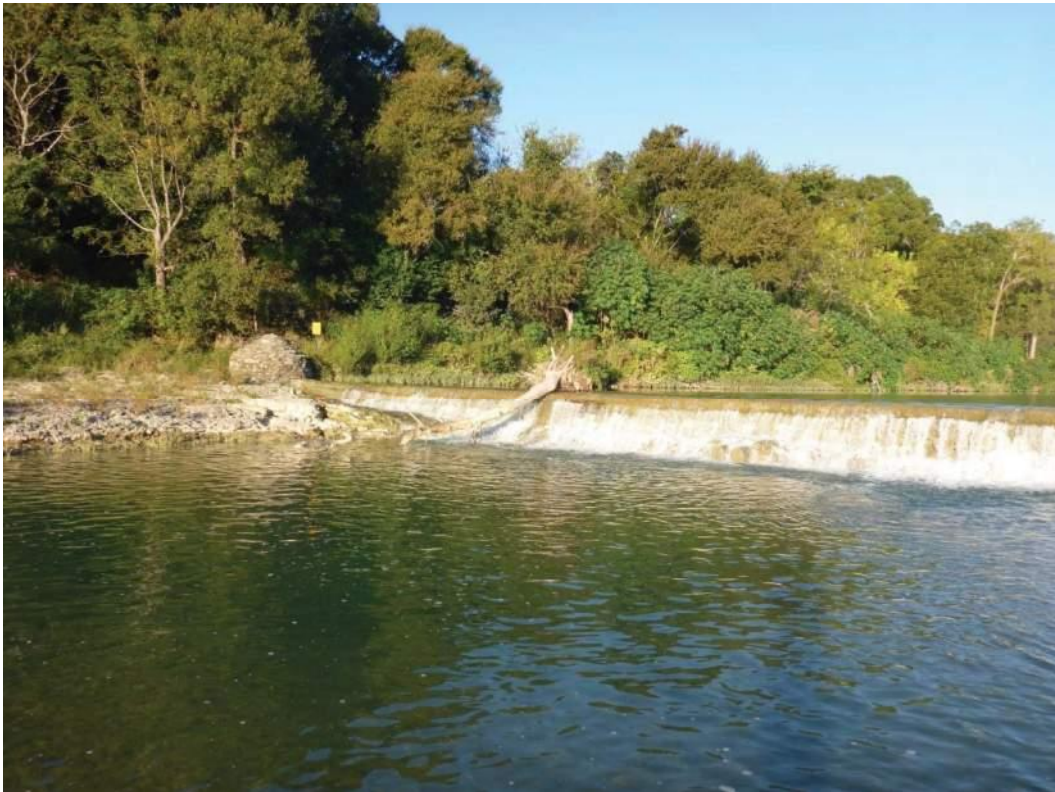
- Heavy vegetation and large trees exist adjacent to the right abutment (Photo 8)

Photo 8 – Vegetation on Right Bank

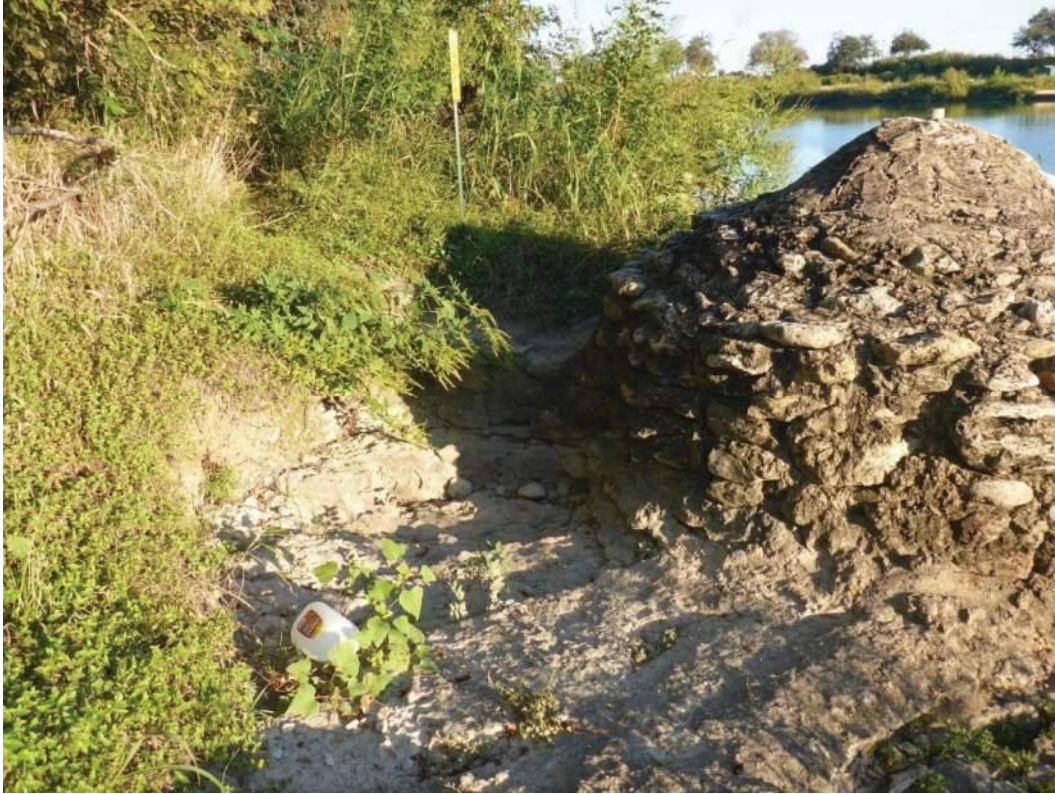
- There is a small pocket of eroded soil on the right bank next to the cylindrical gravity structure (Photo 9).

Photo 9 – Pocket of Erosion at Groin Downstream of the Right Abutment

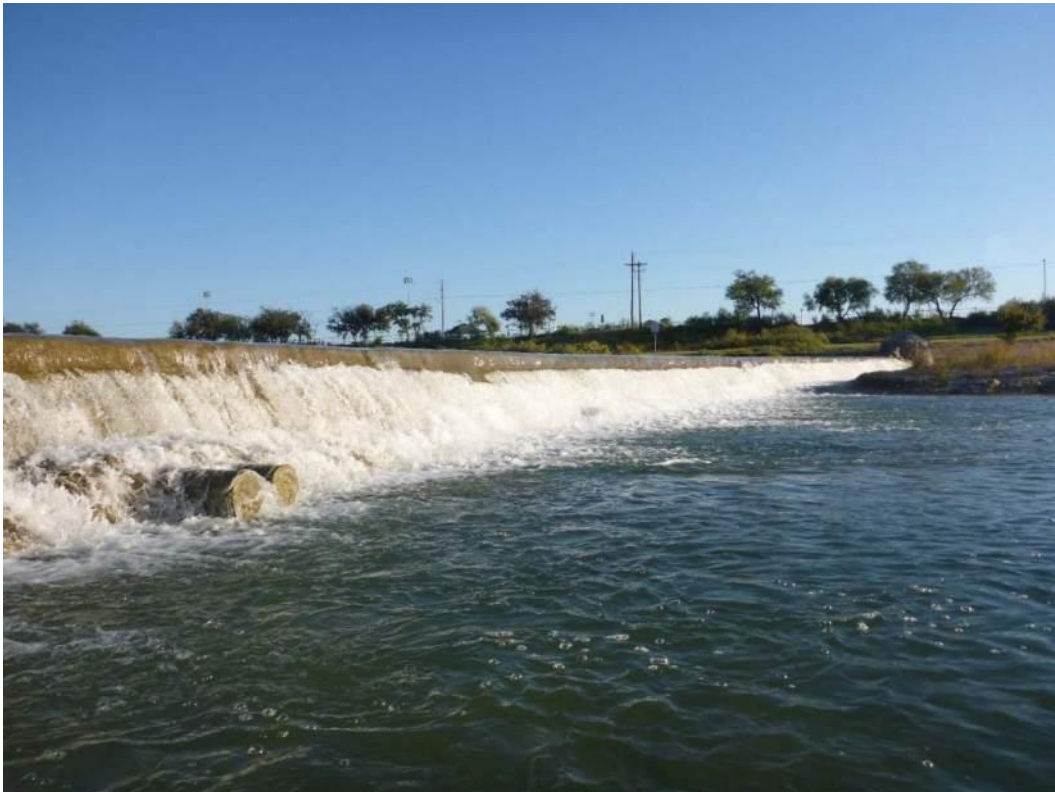
The dam functions as the service overflow spillway or weir and allows regular flows to discharge over the dam. The spillway has two low-level low-flow outlet pipes, but the pipes are infilled with concrete and no longer operational (Photo 10). Overall, it is in fair condition.

Photo 10 – Low-Flow Outlet Pipes with Infill Concrete

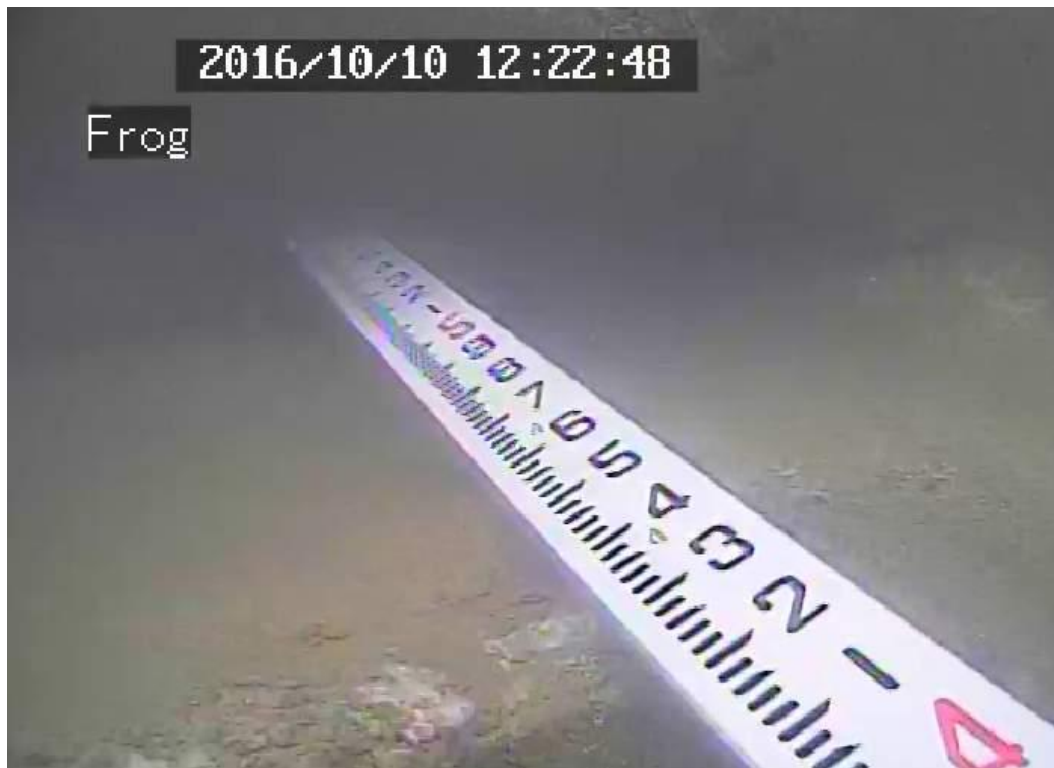
- There were a few minor scour holes downstream (Photo 13) and upstream under the dam (Photo 14). The scour holes generally ranged from 6-inches to 1-foot.
- There was a timber located along the upstream toe (Photo 15). The purpose of timber could not be determined from the dive inspection.

Photo 13 – Typical Downstream Scour under the Dam Toe (Approximately 1.0 feet)

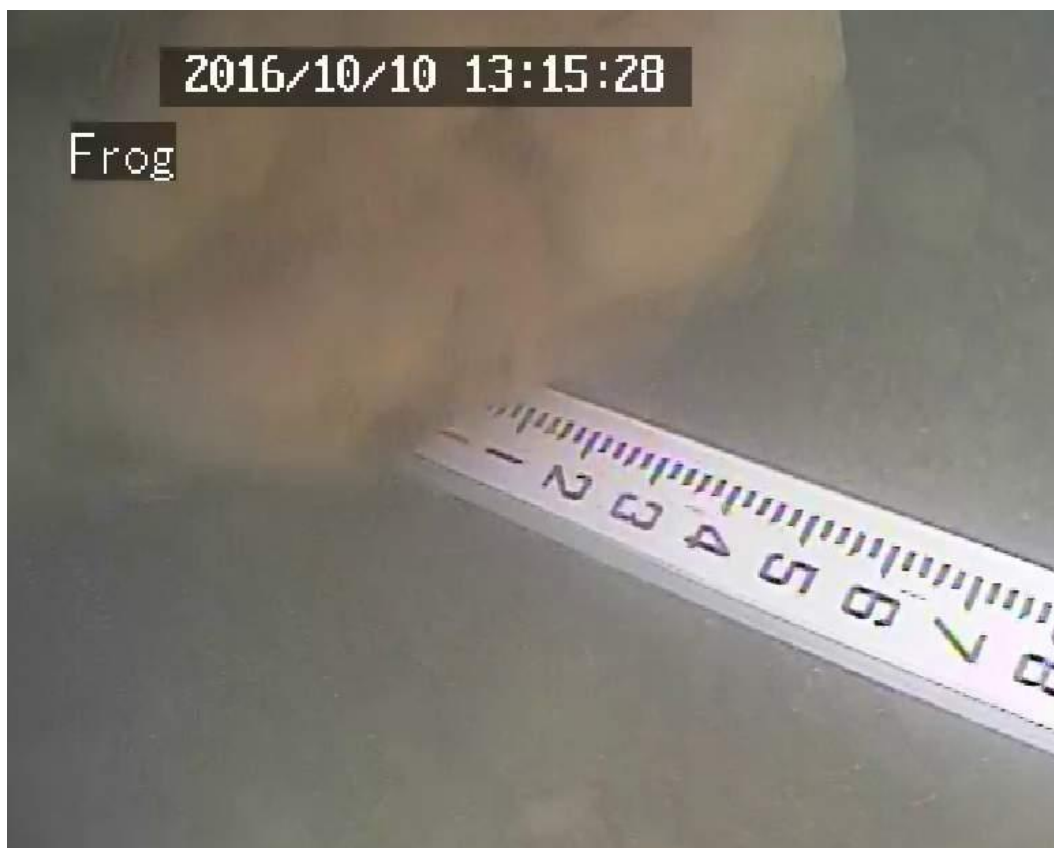
Photo 14 – Typical Upstream Scour under Upstream Heel (Approximately 1.0 feet)

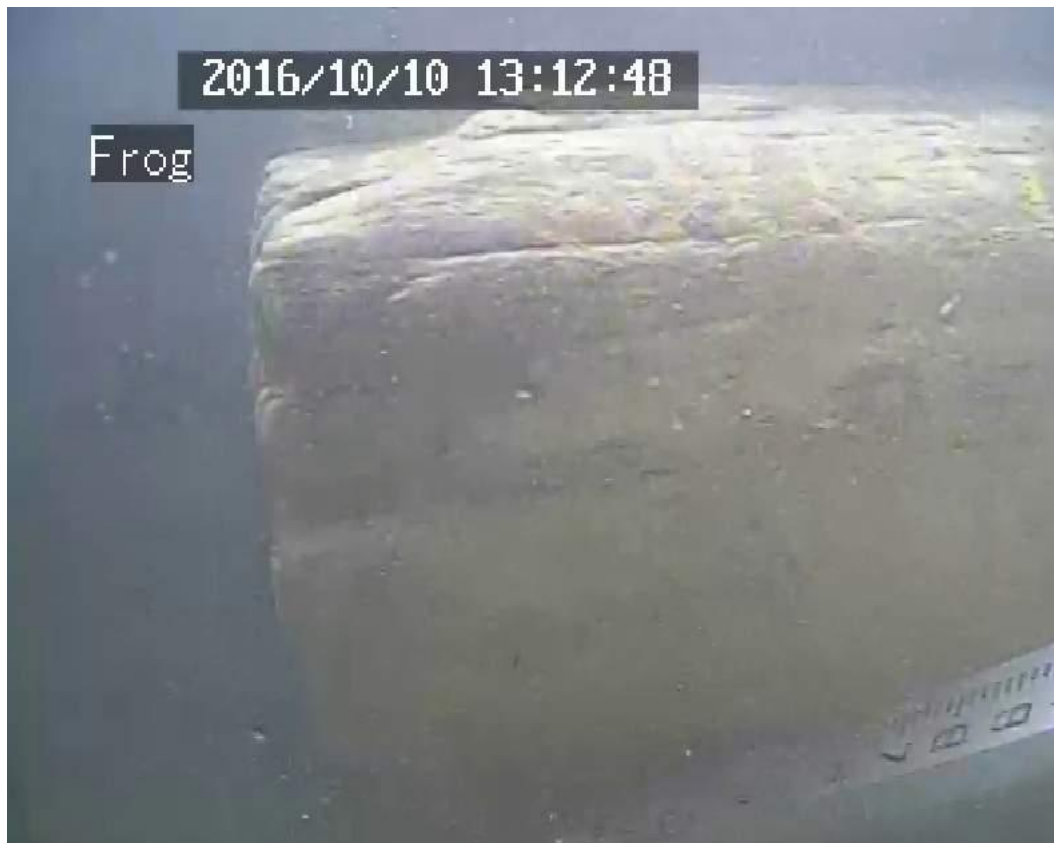
Photo 15 – Sunken Log
