INVITATION FOR PROPOSAL

Solicitation No.:	224-232
Project Title:	Disposition of Mitchell Center (715 Valley St, San Marcos, TX) to a Non- Profit Entity for Public Purpose
Due Date:	September 5, 2024
Due prior to:	2:00 P.M.

PROPERTY INSPECTION REPORT

Prepared For:	City of Sar	n Marcos		
		4)	Jame of Client)	
Concerning:	715 Valley	, San Marcos, Tx 7866	6	
		(Address or Other Id	entification of Inspected Property)	
By:	Ed Foster	Trec. Lc 4850	8/5/22	
	(Name ar	nd License Number of Inspector)		(Date)
	(Name, L	icense Number and Signature of Sponsori	ng Inspector, if required)

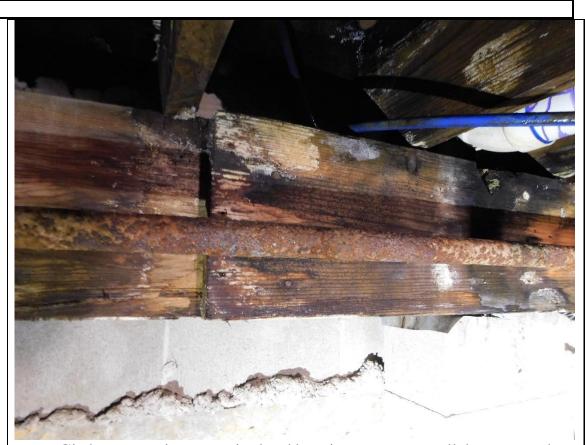
A. Found: Type of Comme	Foundation(s):	I. STRUCT	URALSYSTI	EMS	
rela spa	atively large s ace main girde	tress cracks, flo ers have damage	ors dip and sl at various ar	g as intended as masonry has lope considerably and crawl reas. Various girders/sills are e. Soil under the structure is	Э

Girder separation, exterior load bearing concrete wall damage and black mold in crawl space

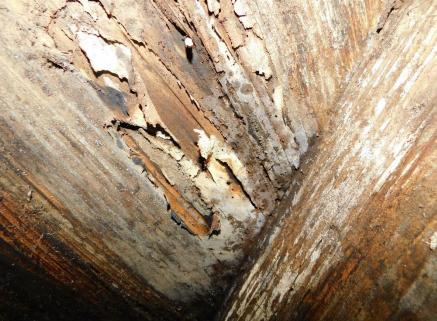
subfloor damage

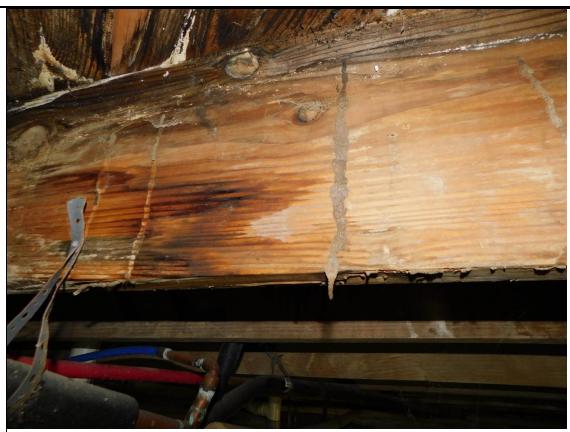
Termite shelter tubes on floor joist

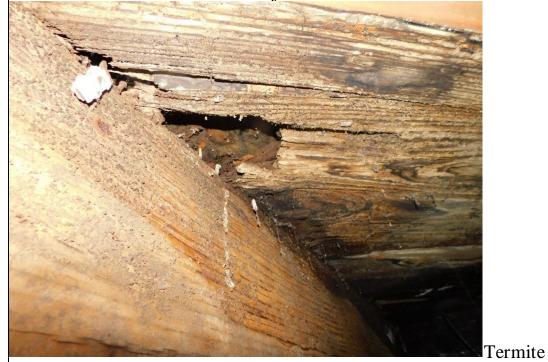
damage to floor joist and subfloor

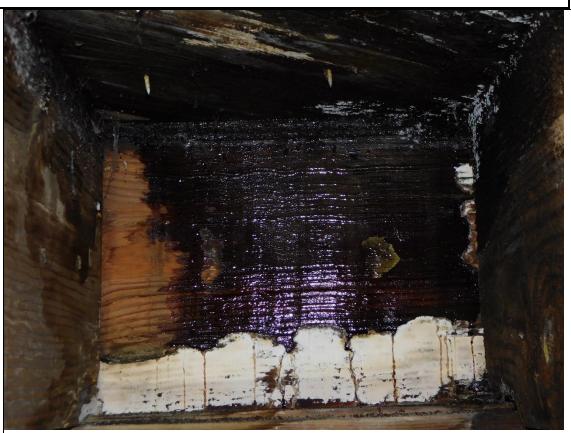
Black mold present with active water leak/subfloor damage

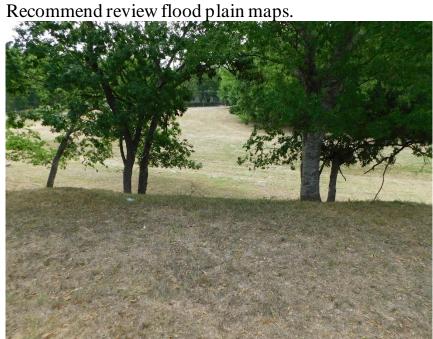
Rear runoff area

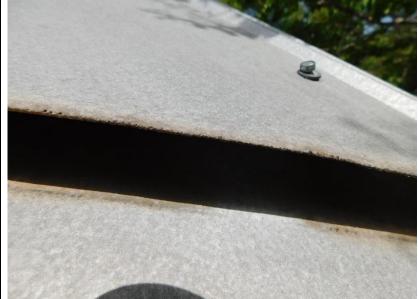
Front center left

Roofing directly walked on for inspection. Small tree limbs contact roof. Some fasteners are not quite secure to the decking and or have grommets damaged. Center left valley metal roofing panel is no longer secure.

valley panel and nearby fasteners not secure

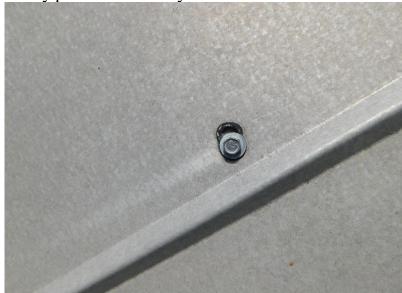
rubber sealing

washer damaged

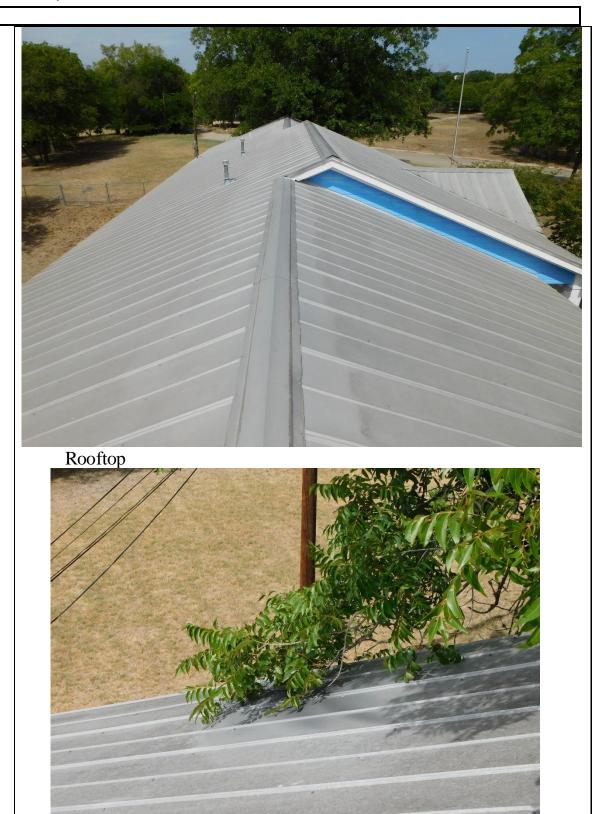
Tree limbs contact roofing

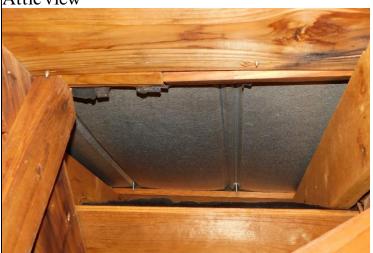
Various roofing fasteners do no secure to joists

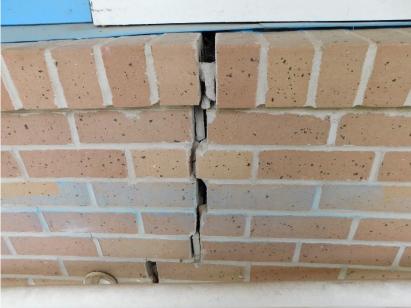
Exterior masonry has stress cracks and exterior siding is damaged at numerous areas—worse near window exteriors. Exterior wall flashing and damaged covering allows for water penetration behind the exterior sheathing. Note—not inspected for lead based paint, asbestos, ADA compliancy, or cosmetic issues. Also, City of San Marcos may impose stricter standards than National codes call for.

Large perimeter

brick wall stress crack

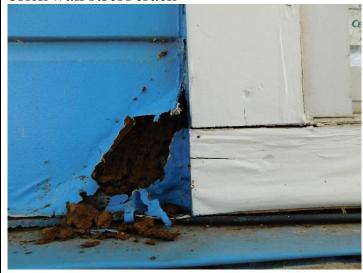
Exterior wall water damage to Masonite siding

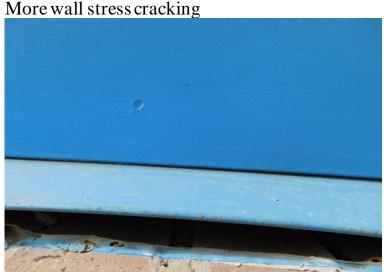
Exterior wall flashing allows water to enter structure

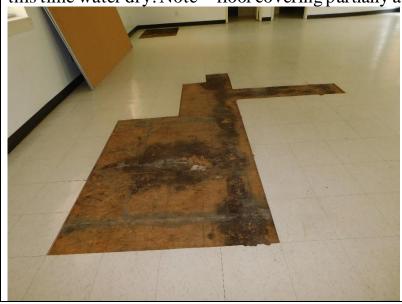
Floors slope and dip, subfloors are damaged at water areas—worse at left bathroom, and have black mold present. Subfloors have major water damage at left. Some areas of ceilings have water damage—hall area damage may have been from a previous air conditioner leak. AC pan at this time water dry. Note—floor covering partially absent at main room

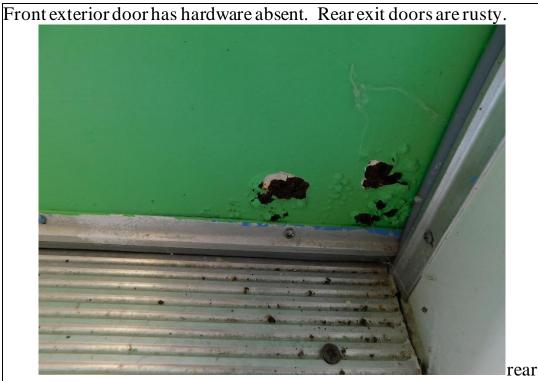
exterior door rust damage

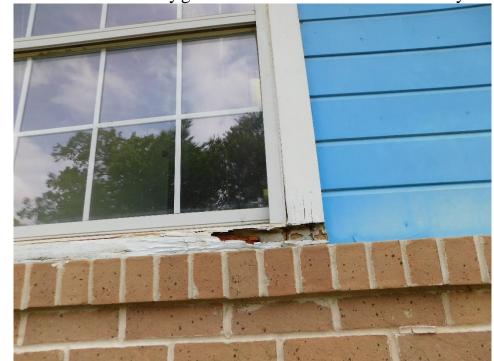
Most windows would not open, have glazing damage and have exterior trim damaged. Cracked panes at right rear and left rear and screens are absent. No safety glass found at windows near doorways.

Exterior window trim damage

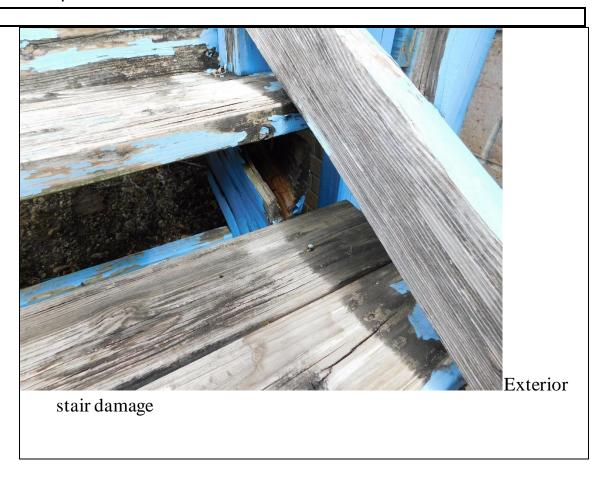
Exterior stairs are damaged at all areas and is a safety concern at this time—worse at right rear. Note—no ramps present at stairways.

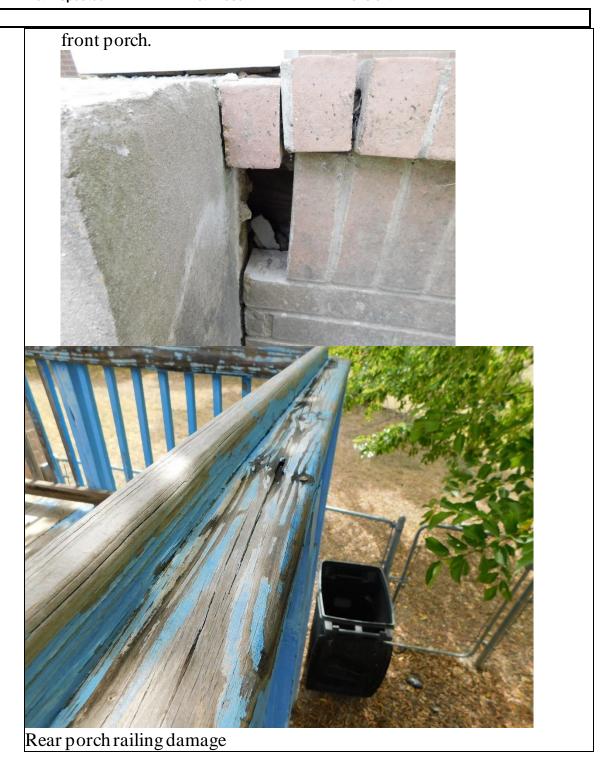
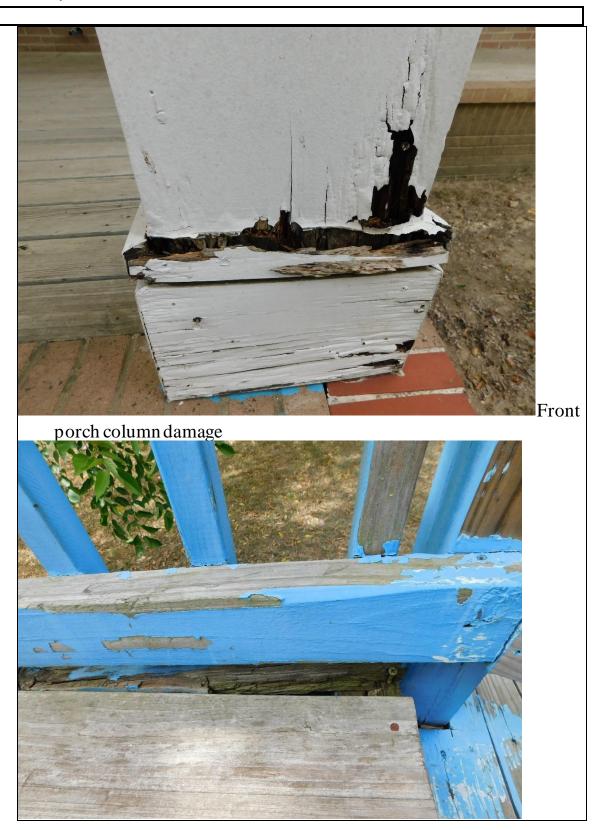
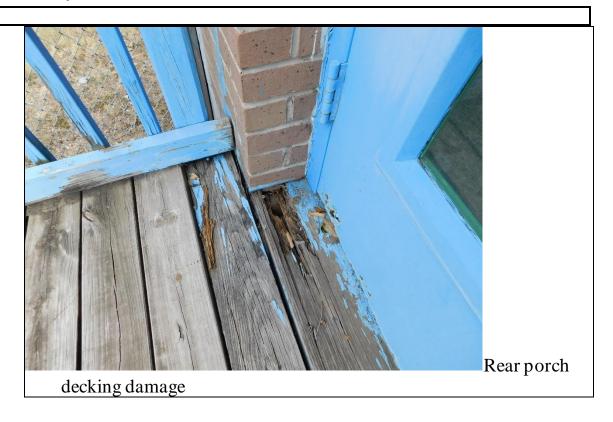
Exterior porch decking and railings are damaged and are a safety concern at this time at rotted areas. Front porch roof support columns are damaged. Some masonry is damaged at the lower perimeter of the

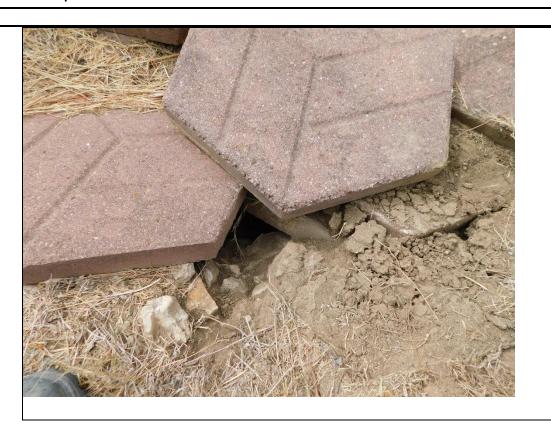
Security system not inspected. Hole present covered by masonry tile at right rear---trip hazard.

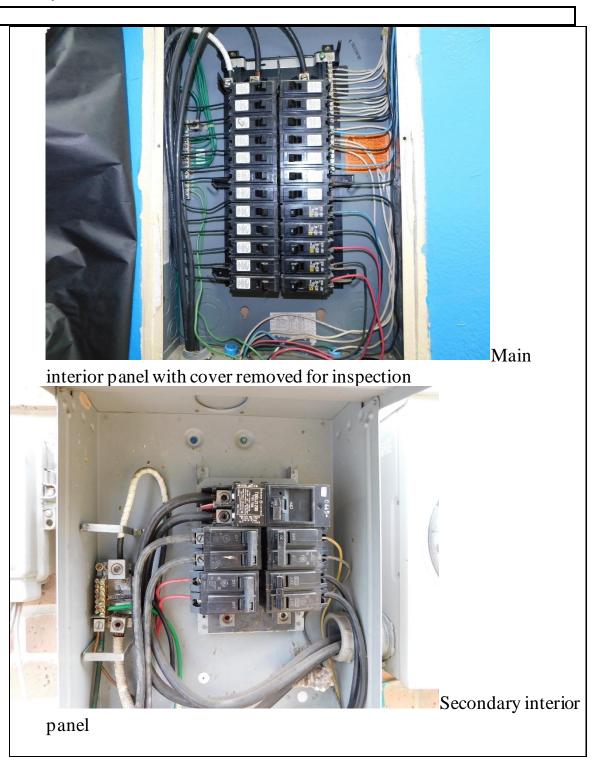
Interior small panel has grounds and neutrals tied together instead of floating and lacks breaker labeling.

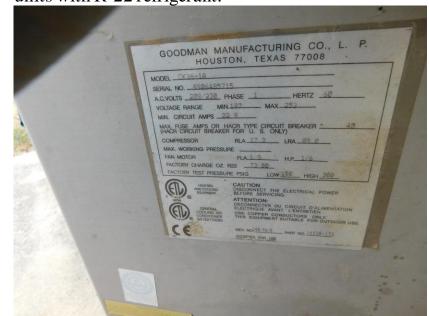
Only a 10 degree differential was measured for the left side of the structure. . 16 to 20 is considered good. Unit for the right side of the structure was completely inoperative. Condenser fins are damaged at both units. Note—A-coils were not directly visible. Recommend contact licensed HVAC technician for further evaluation. 2 1999 3 ton units with R-22 refrigerant.

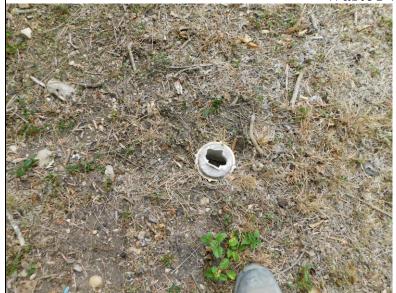
Sewer clean out is damaged at right. Note--Most of the waste piping has been upgraded to PVC. Most commodes had lost their weirs/water traps—this can be caused by window blowing past the plumbing vents or inadequate venting.

Damaged clean out
