**DATE:** August 22, 2022  
**TO:** Sam Marcos Activity Center  
**ATTN:** Jessica Ramos, CPRP, AFO, Manager  
**FROM:** Ken Dickensheets  
**RE:** Activity Center Audio-Video System Assessment

San Marcos Activity Center  
Audio-Video System Assessment

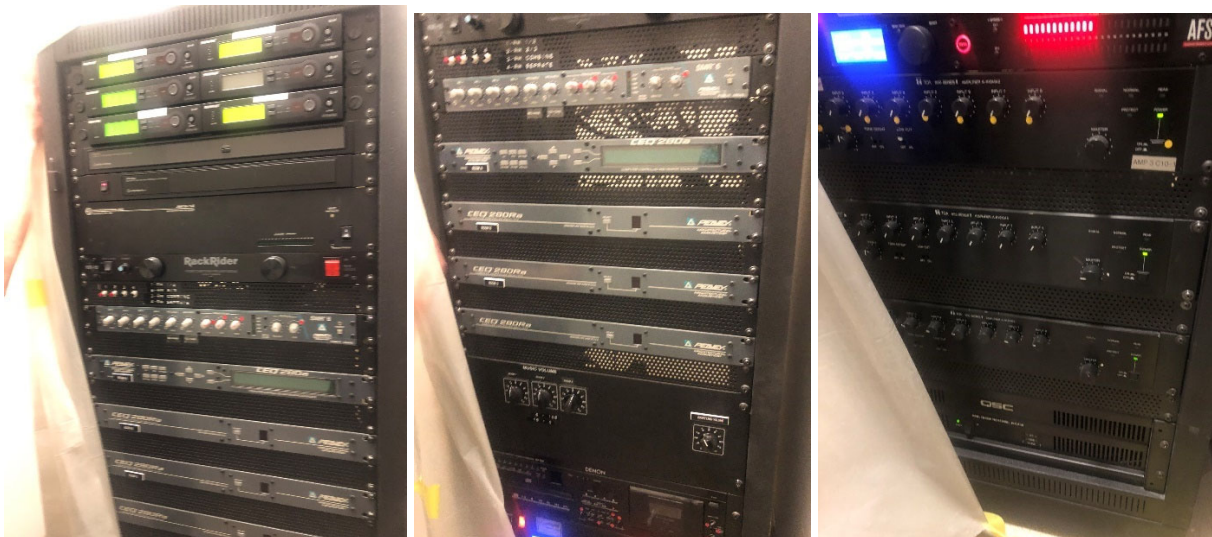
Either during or after the initial construction sound and paging systems were added to the building, however no documentation could be found. These systems are located in a central media closet near the main entry reception desk in a single large electronics rack. The equipment is mostly all vintage of the estimated construction time period about 1997.

Existing sound system equipment located in main electronics rack.

None of the equipment is manufactured any longer nor is any of it even repairable. The wireless microphones appear to be on unusable frequencies. The room is too small.

1. The system components, without exception, are no longer manufactured nor even repairable. Existing wire and cable is either in poor condition or the wrong type. Therefore, the entire sound system needs to be replaced.
2. Add video presentation to the ballroom and pre-function area.
3. Provide water resistant wireless microphones for the activity areas.
4. Add an outdoor sound system
5. Extend the paging capabilities to all areas of the facilities.
6. Add a sound system and flat screen monitor to the small meeting room adjacent to the offices.
7. Provide touch-panel controls in the large banquet/meeting rooms with both user and building personnel controls with password protection.
8. Extend the banquet/meeting room systems to the pre-function area.

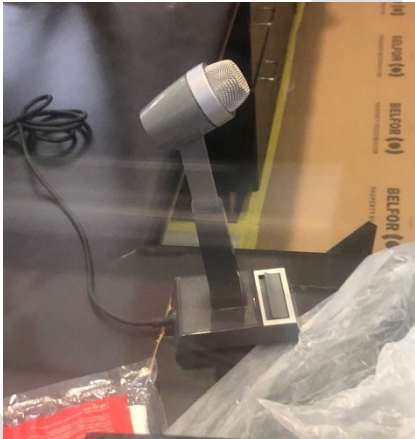
The system has paging capability into the hallways and some meeting spaces, however the quality and sound coverage is poor at best. There are 4" diameter speakers located around parts of the entry area but they provide sound coverage only to the perimeter of the space which means anyone in the main part of the entry or adjacent to it cannot understand or even properly hear what is being said. There are speakers in the main hallways also but they are spaced too far apart to provide adequate sound coverage. Part of the paging system is a low quality, two-way radio type microphone which has limited frequency response. The push-to talk controls for this microphone are intermittent and unreliable.

Microphone at main entry desk.

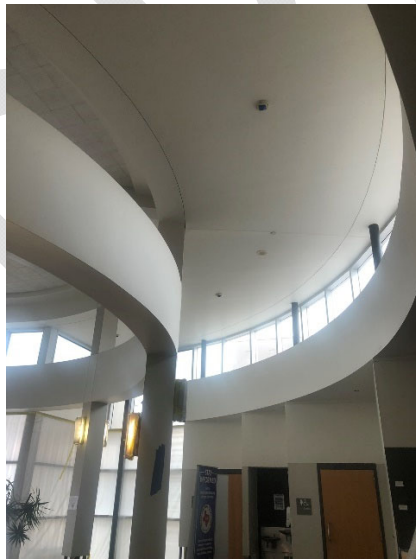
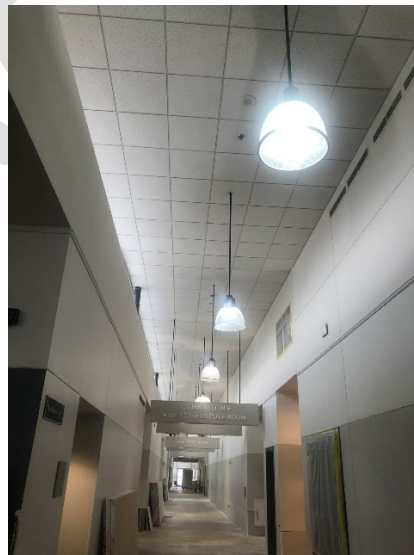
Ceiling speakers at entry and side hallways.

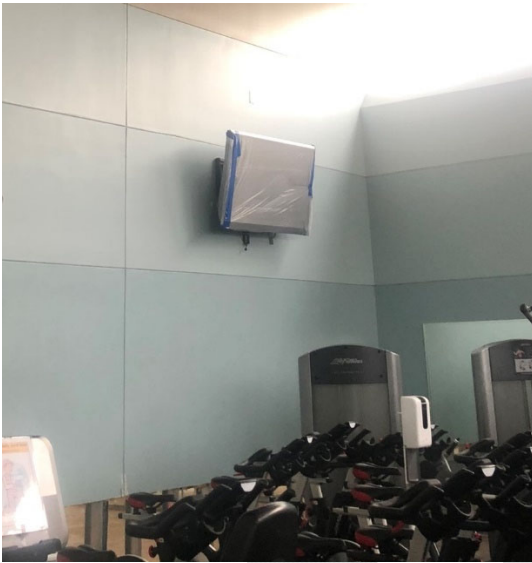
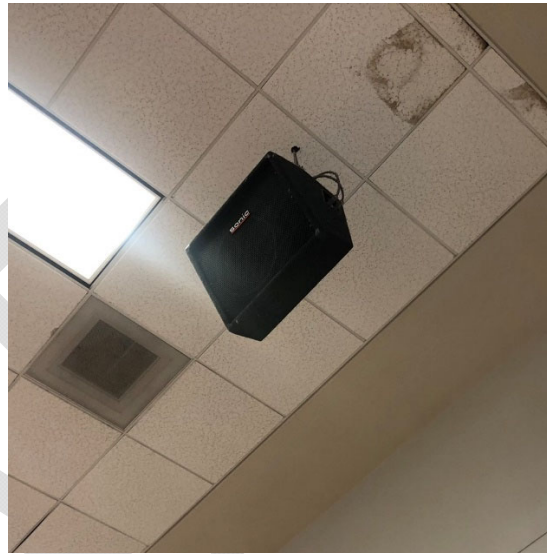
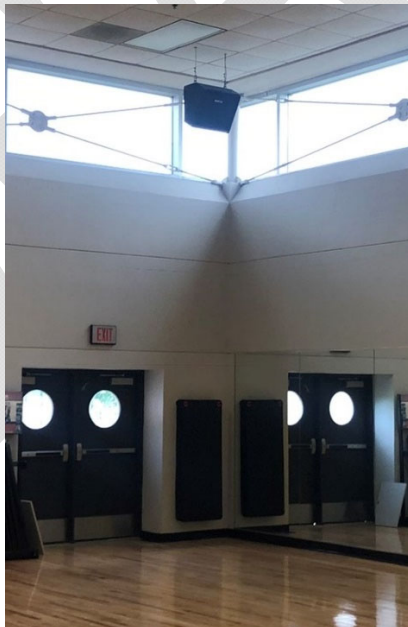
Music store, band style loudspeakers have been installed in the aerobics room, the weight room and the new aerobics rooms but they are outdated. In some cases there is a local amplifier, CD player, and wireless microphone but all of this equipment is both outdated and under-powered for the intended use. In other locations, the equipment is missing.

Suspended speakers at weight and aerobics rooms.

This will include all new electronics, loudspeakers and controls. Loudspeakers will be added to all areas including the swimming pool, the outdoor area, the banquet/meeting pre-function area -- all with proper spacing. New loudspeakers will be installed in the banquet/meeting rooms and replaced in the exercise rooms.

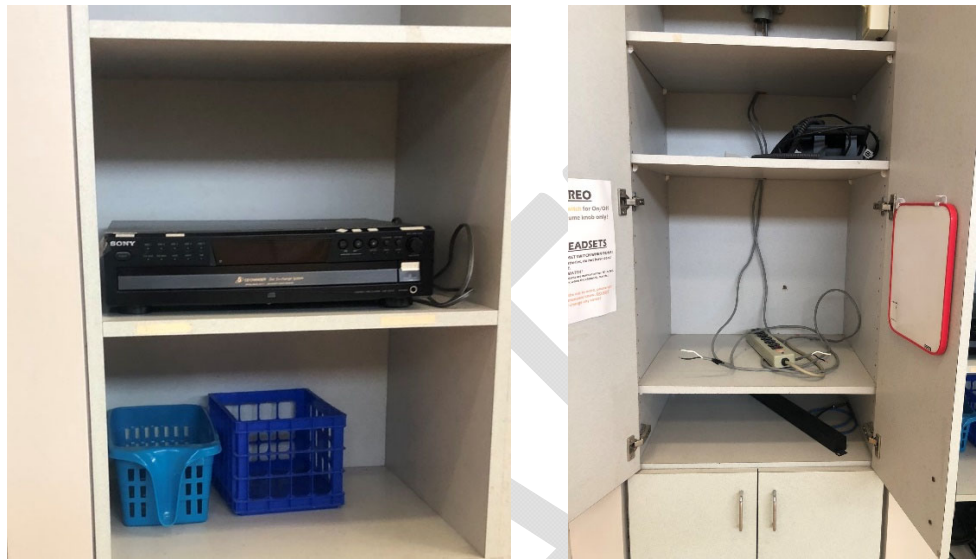
Most of the equipment in the weight, aerobics and swimming pool areas is consumer grade and is not designed for this type of use. In all cases it is underpowered resulting in very poor sound quality and high distortion levels. It is missing and assumed failed in some of these rooms.

Equipment and missing consumer grade equipment.

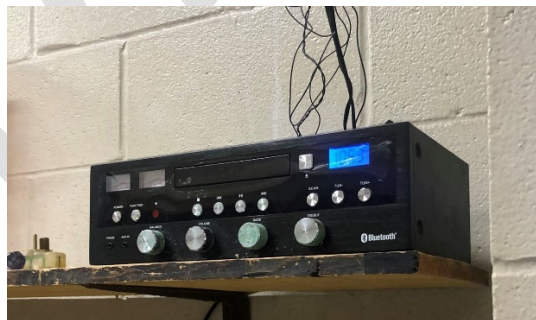
The swimming pool equipment is also consumer type and includes loudspeakers that are inadequate for the use, are not directional enough for the reverberant acoustics of the pool and of insufficient quantity to provide usable sound for instruction, background music or even paging. They are mounted incorrectly causing the already poor-quality sound to be even worse. To be usable, highly-directional speakers mounted over the entire pool area are required and need sufficient power to provide undistorted sound. A water-proof wireless microphone is needed for group instruction.

The pool amplifier is a consumer grade product and does not provide sufficient power for the system.

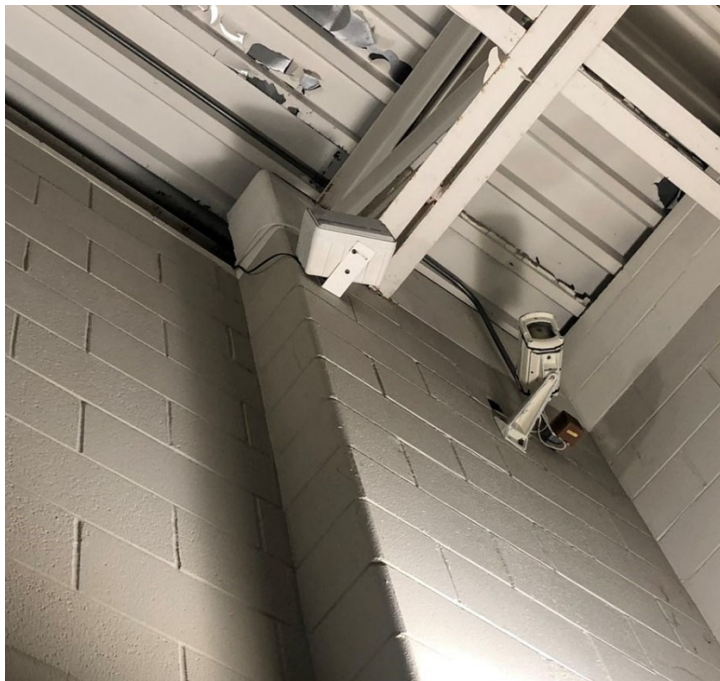
Pool loudspeakers are the wrong type and mounted/aimed incorrectly.

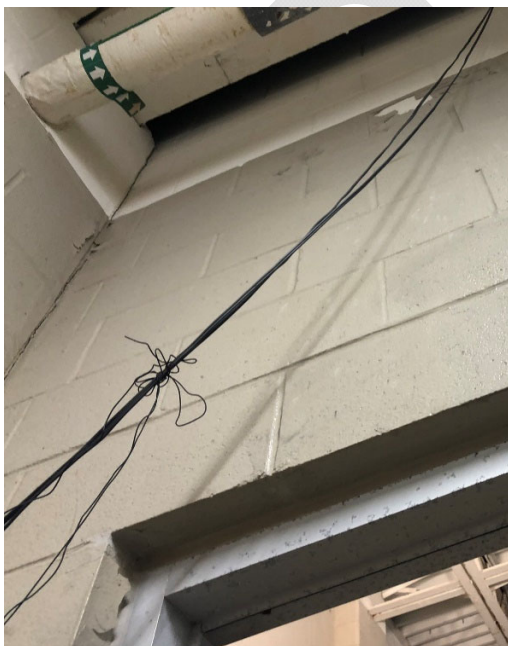
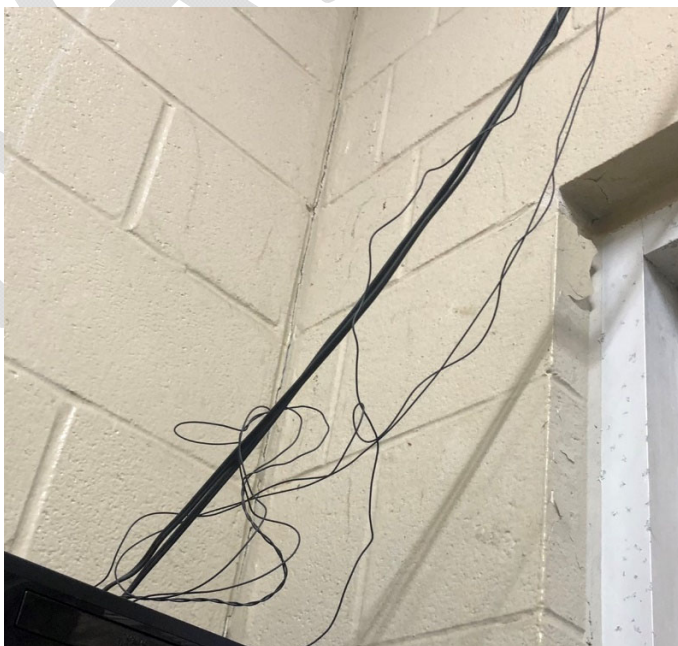
Wiring is exposed, unprotected and generally messy.

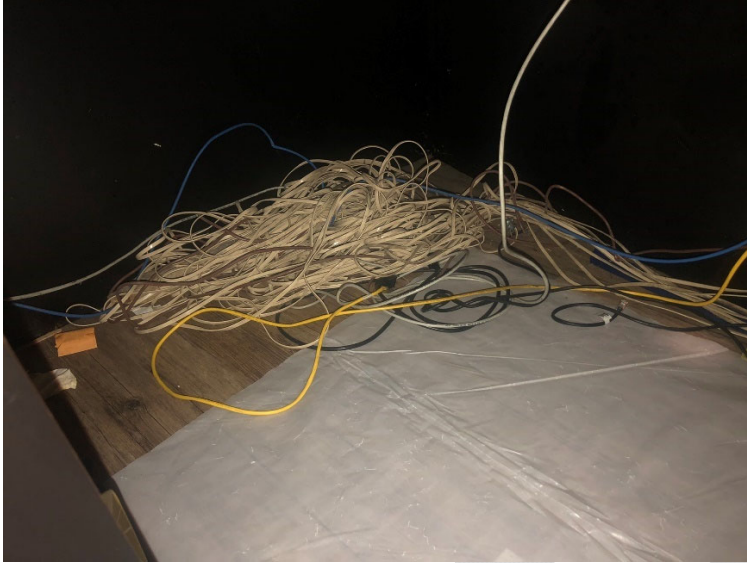
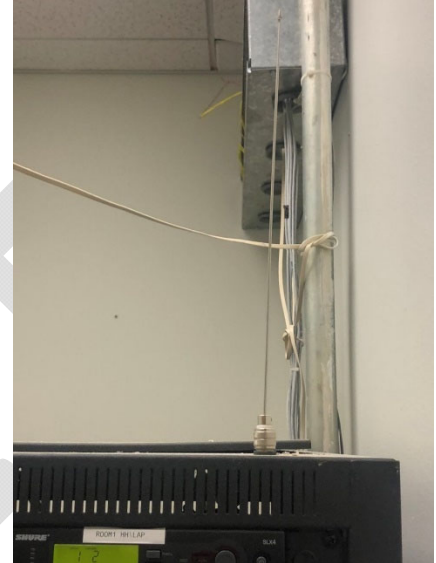
Wire and cabling throughout the facility is not neatly installed and is prone to damage.

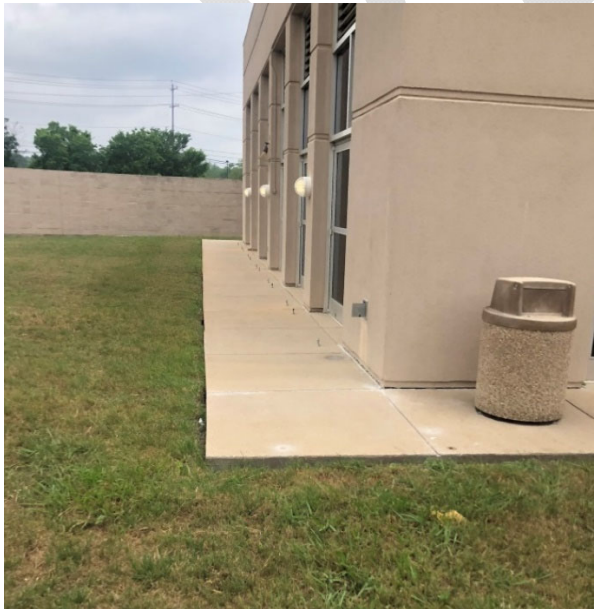
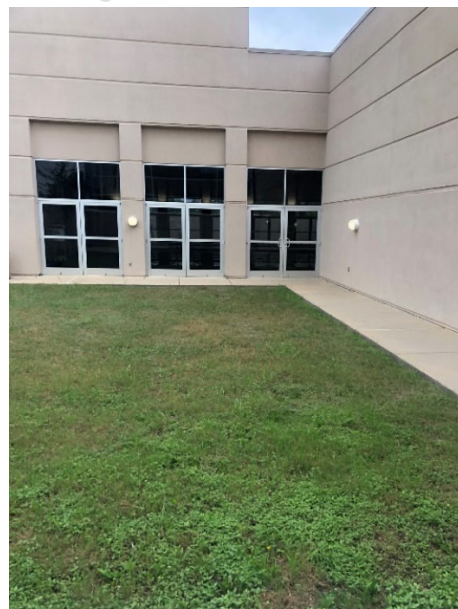
Sound support for the outside activity area is missing but could be used to support activities held in that area as well as to provide enhanced safety with delivery of paging and announcements.

The outdoor activity area has no sound support.

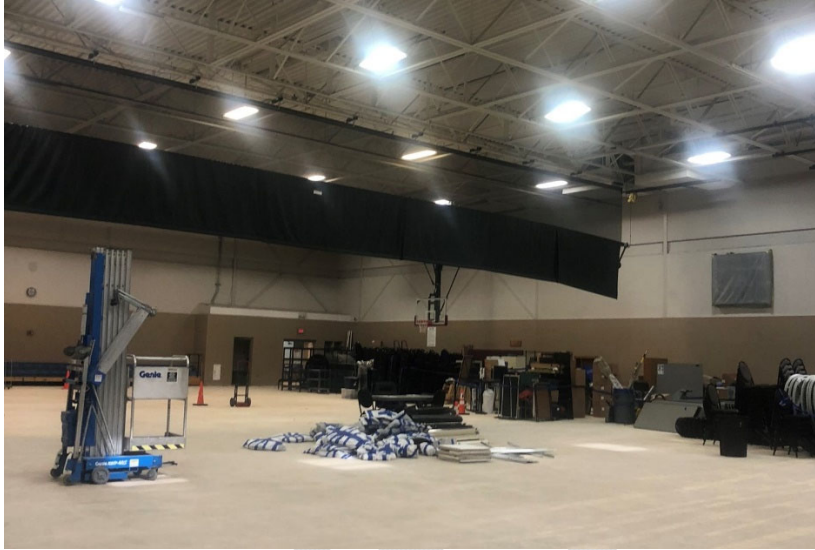
There is no sound system in the large basketball gym for announcing events, crowd control, instruction or background music playback.

There is no sound system serving the basketball courts.

9. Add a sound system into the basketball courts.

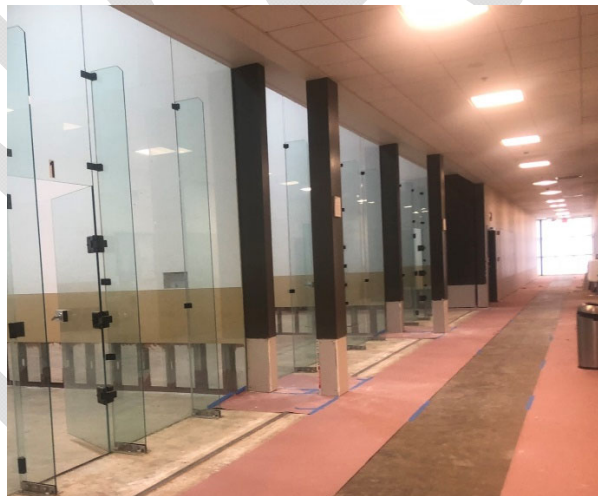
Handball court area.

There are no speakers for announcements or paging in the handball courts nor the adjacent hallway.

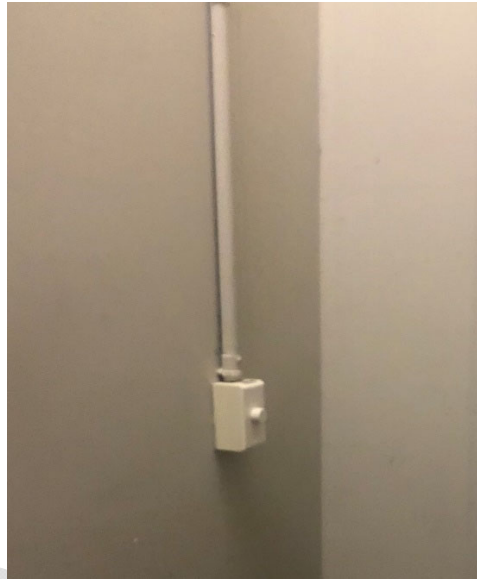
inadequate and locked in storage closets. Video projection screens are absent as are video projectors. There is no capability to extend events from the large meeting rooms out to the pre-function area nor to allow that area to operate independently.

Sound system level controls are locked in storage closets and provide inadequate control for users or activity center personnel.

Touch panel controls for each area will be installed in that same area. These touch panels will allow users or in-house personnel in that room to have limited control over functions, sound levels, and microphones within that room only. A similar touch panel will be installed at the main reception desk to control paging to any or all areas, background music levels, and so forth. For those rooms requiring music capability such as the exercise rooms, a local MP3/Bluetooth input will be available and controllable from the touch panel in that room.

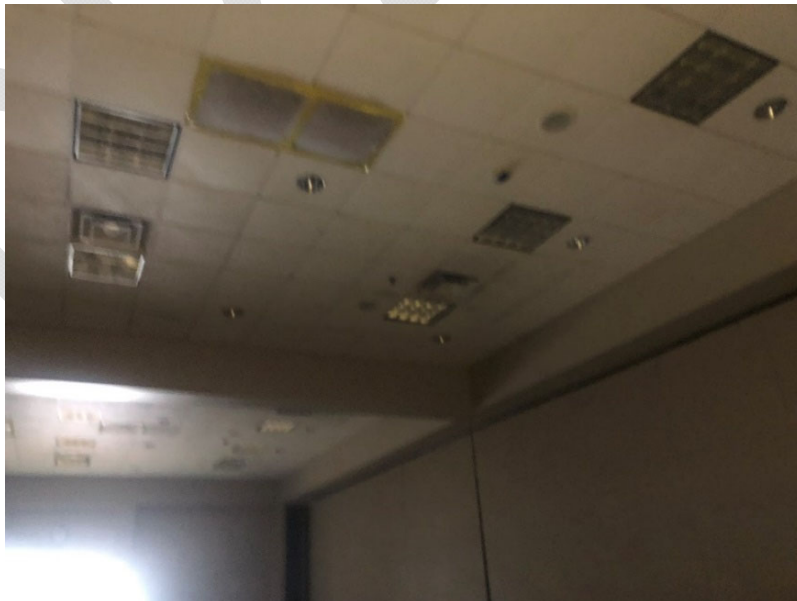
Basic video support for meetings is missing. There are no projection screens nor projectors.

Projection screens and video projectors will be added to each section of the meeting/banquet room. A large flat-screen monitor will be added to the small meeting room. Each room will have a local HDMI input for a laptop computer or other video source. In the large meeting/banquet rooms, the three projectors will show the same image when the rooms are combined into one large room or a smaller double room. Flat screen TV's will be added to the lobby/pre-function area for independent use, signage functions or connection to the banquet halls.

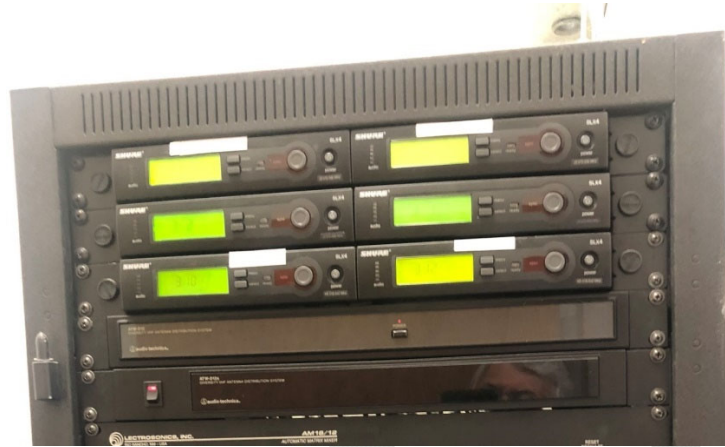
Parts of the wireless mics for the banquet/meeting rooms are missing and the models are operating on illegal frequencies (as of 2019).

New wireless microphones will be provided for the exercise rooms, meeting and meeting/banquet rooms, swimming pool, basketball court, and outdoor activity area. These rooms will also have Bluetooth inputs for connection of user devices to the systems.
