Supplemental Cape's Dam and Mill Race Assessment

City of San Marcos

Dr. Thomas B. Hardy, Ph.D.

May 23, 2017

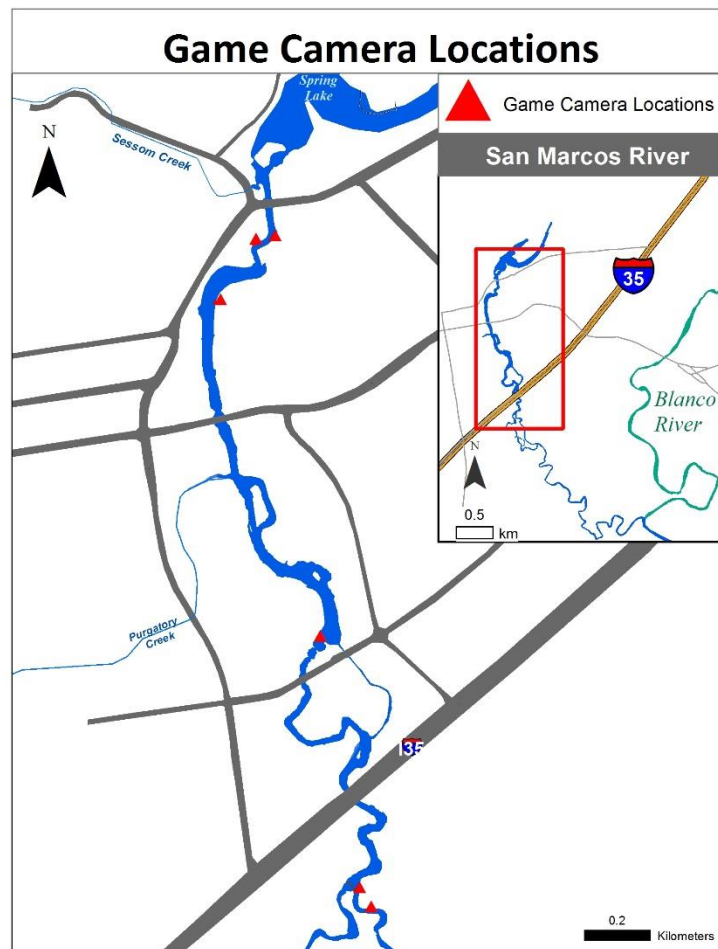
Figure 5. Game camera locations on the San Marcos River.

Two game cameras were placed at locations near the juncture of Cape's Dam and the Mill Race from July – November 2016 (Figure 5). Cameras were placed facing the river allowing for the widest view possible and programmed to capture images once an hour for nine hours a day (dusk to dawn).

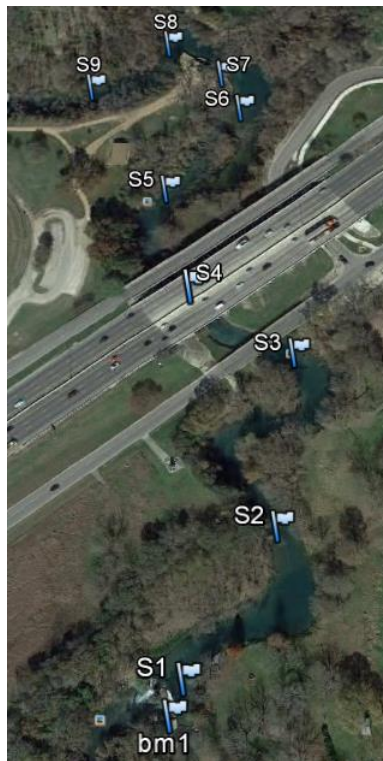
Figure 7. Surface water elevation points above the Cape's Dam and the Mill Race - San Marcos River (12/16/2016)

Nine surface water elevation points were collected along the longitudinal profile upstream of Cape's Dam (Figure 7).

Surface water elevation in the San Marcos River showed minimal slope between IH35 and Cape's Dam. However, once upstream of IH35 (i.e., ~350 meters upstream of Cape's Dam), the surface water elevation sloped up considerably and marks the upstream extent of the back water from Cape's Dam (Table 4; Figure 8). This profile is consistent with the previously reported upstream extent of the backwater based on field measurement and simulated by the hydraulic modeling under the presence of Cape's Dam reported in Hardy and Raphelt (2015). Discharge in the San Marcos River at the time of measuring the surface water elevation was approximately 245 cfs. As would be expected from the fundamental properties of hydraulics of river channels, the upstream extent of the backwater would move progressively downstream under lower San Marcos River discharges (e.g., median flows ~ 175 cfs).

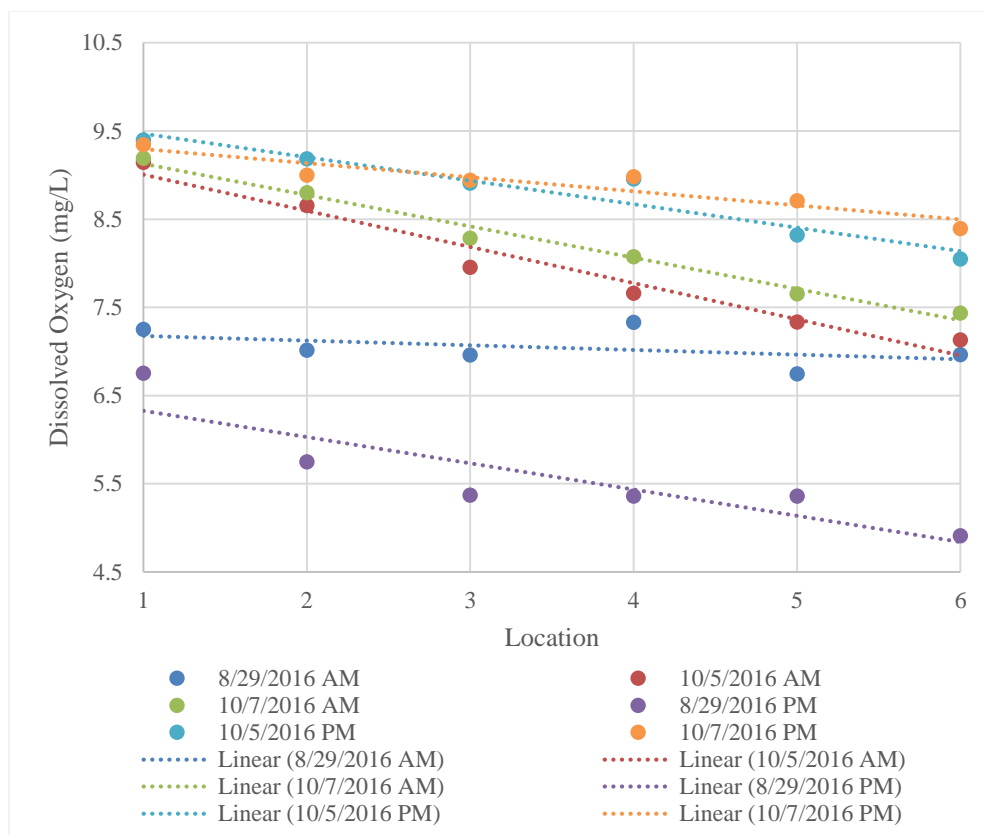
Figure 13. Observed profiles of dissolved oxygen (mg/L) in the Mill Race on 8/29/2016, 10/5/2016, and 10/7/2016.

Water quality parameters taken on 08/29/2016, 10/5/2016, and 10/07/2016 are noted in Table 5. The range of turbidity observed in the Mill Race (1.12-6.97 NTU) was greater than in the San Marcos River (0.87-2.87 NTU). Dissolved oxygen generally decreased longitudinally in the Mill Race during all sampling periods (Figure 13) and is attributed to the lack of turbulent reaeration that is more reflective of conditions in the main channel of the San Marcos River. Other water quality parameters did not exhibit a longitudinal change within the Mill Race during these sampling periods.

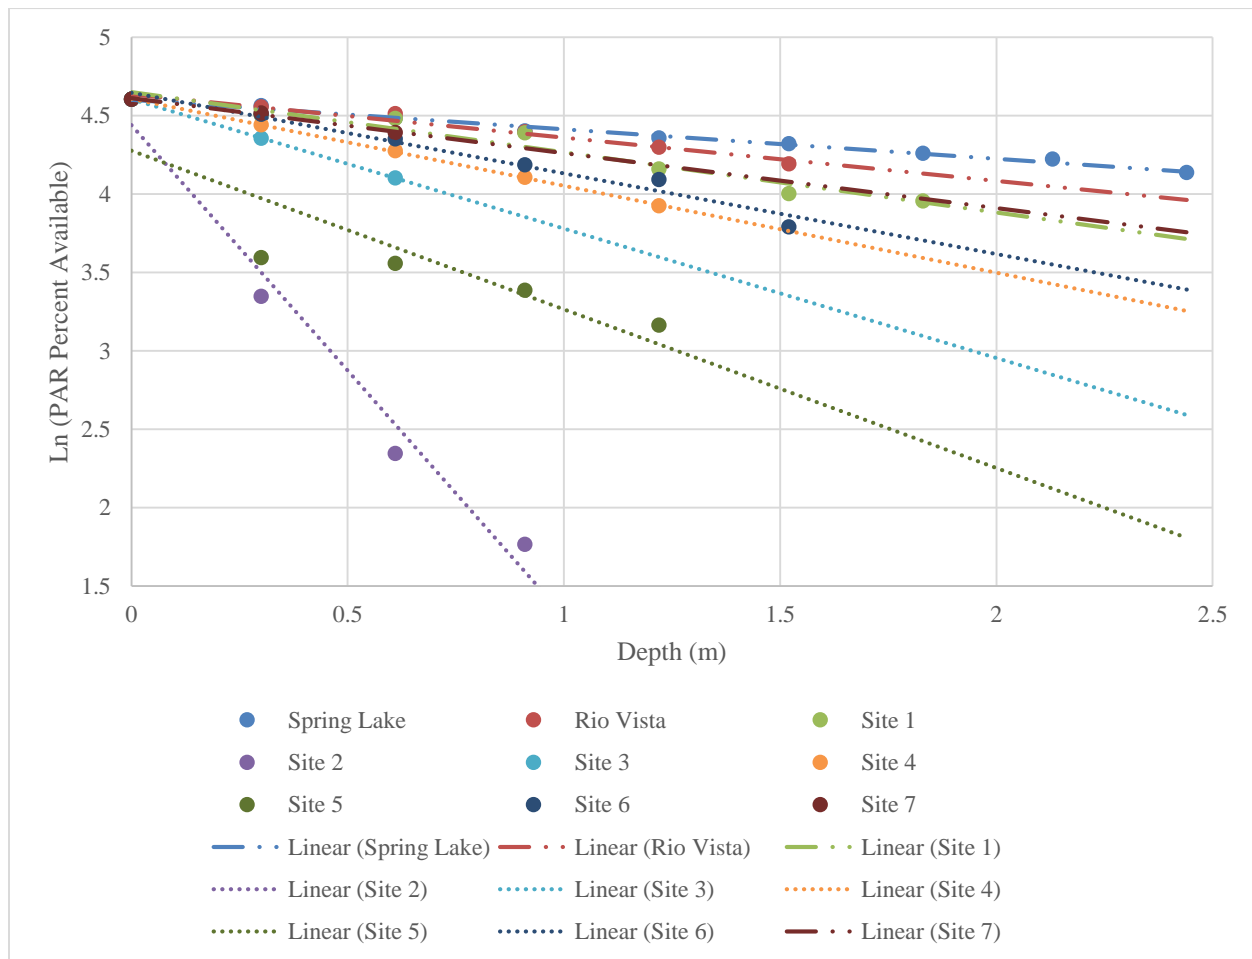
Figure 14. Percent PAR reduction among sites in the San Marcos River (---) and the Mill Race (.....).

Table 6 denotes photosynthetic active radiation (PAR) values and canopy closure for all sites on 08/15/2016. Canopy closure observed in center of the channel among sites in the San Marcos River (0%) was lower than the canopy cover found in the center channel among sites in the Mill Race (54-71%). Figure 14 illustrates the difference in the amount PAR reduction between the San Marcos River and the Mill Race. In general the rate of PAR reduction was greater in the Mill Race than the San Marcos River. Regression slopes for PAR reduction ranged from -0.19 to -0.35 in the San Marcos River whereas the slopes for PAR reduction ranged from -0.55 to -3.13 in the Mill Race (Table 7). Greater canopy closure, sun angle orientation, and water clarity likely attribute to the higher rates of PAR reduction in the Mill Race compared to the San Marcos River.

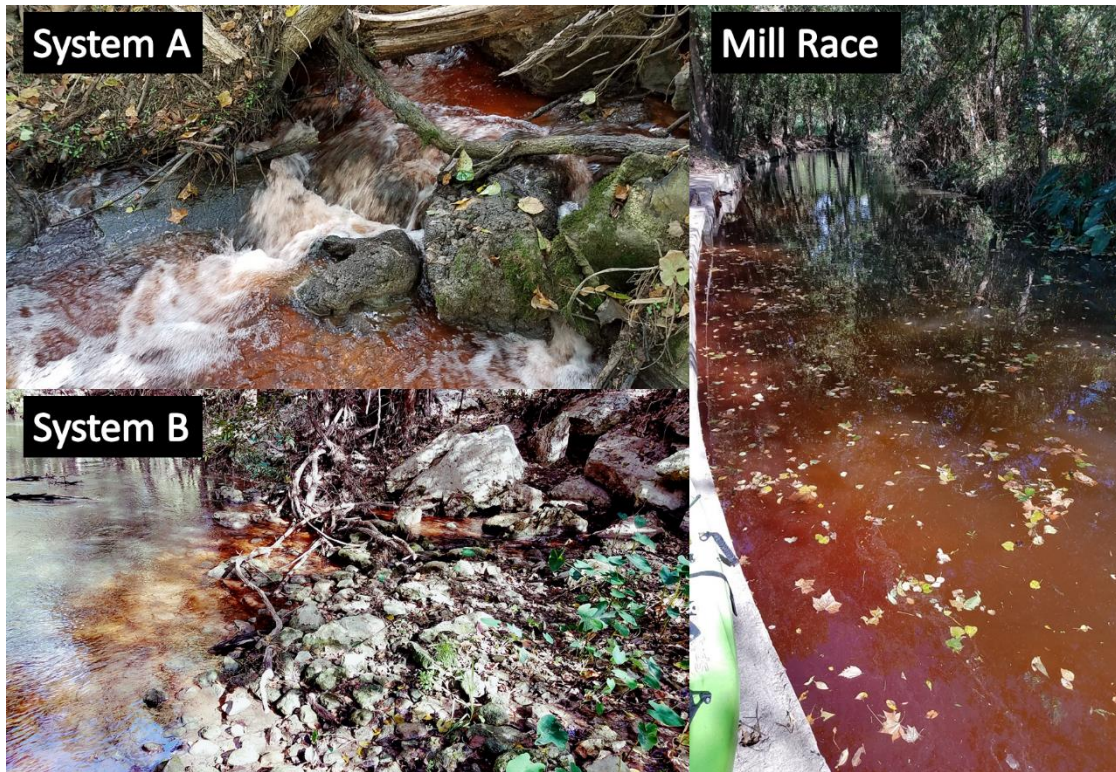
Figure 17. Seepage System A and B after the introduction of red dye in the Mill Race above Cape's Rd.

Two seepage outflow systems (denoted seepage System A and System B) were detected flowing in to the San Marcos River from the southwest region of Thompson's Island. Seepage outflow locations and discharge sampling locations (e.g. Mill Race Opening, Mill Race Upstream (of Cape's Road), Mill Race at Cape's Road.) are shown in Figure 16. Vibrant red hues were observed in both the System A and System B outflows within ten minutes of disbursing red-dye in the adjacent segment of the Mill Race just above Cape's Rd (see Figure 17). Observational red-dye testing confirmed the Mill Race to be the origin of seepage outflow for Systems A and B.
