# DAM EVALUATION REPORT

## Five Mile Dam (Hays County Park Lake Dam) TX04659

Five Mile Dam (also known as Hays County Park Lake Dam) was inspected by Freese and Nichols (FNI) on the morning of January 8, 2025. Based on visual inspection, the dam is in fair condition.

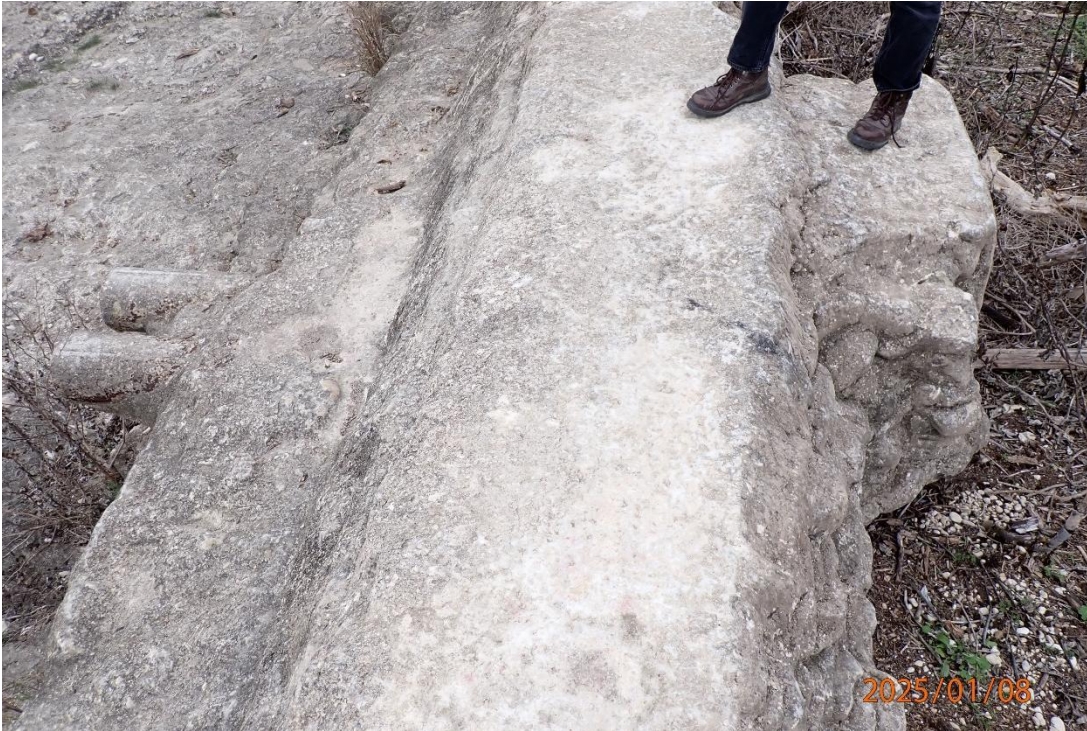
Photo No. 17: Decommissioned low flow outlet

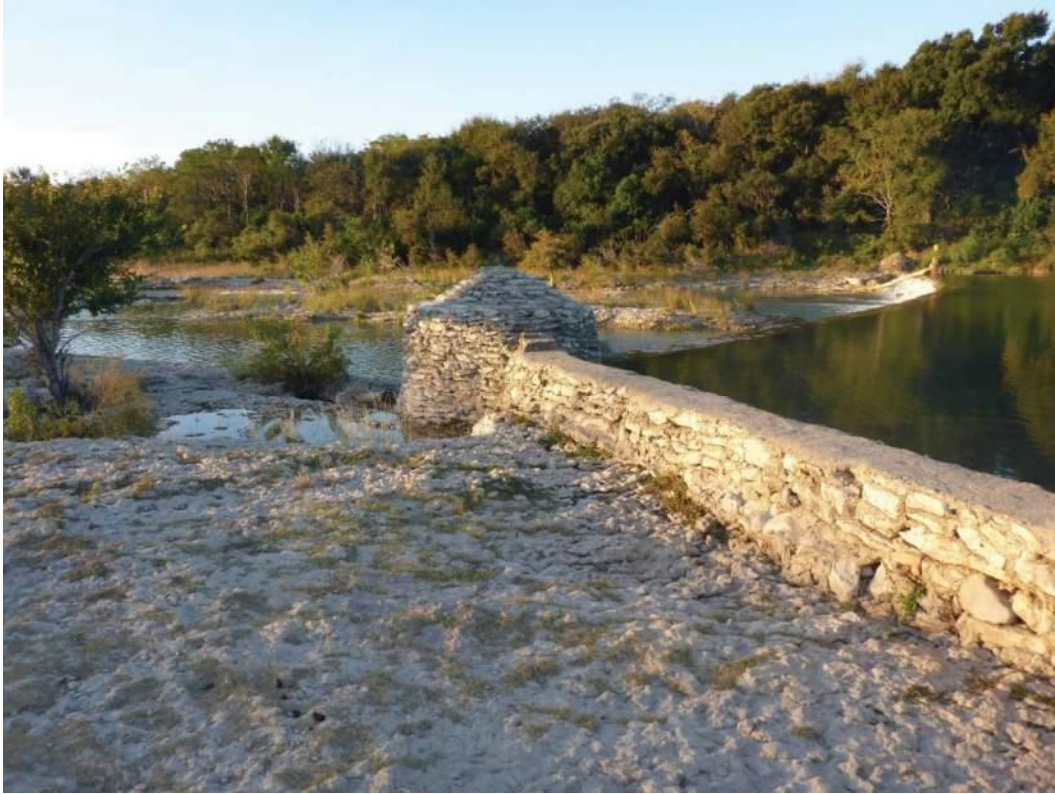
During the inspection, there was significant flow over the top of the low flow section of the dam, which limited visibility and accessibility. The cross-section of the dam was not immediately visible, but the abutment indicates a limestone mortar (masonry) construction (Photo 1). All observations were either made from the shoreline or downstream accessible areas. In addition to the visual inspection, Hays County performed a diving inspection on October 10<sup>th</sup> that documented the underwater condition of the dam with video. Figures 1 and 2 shows an aerial photograph of the dam and the surrounding areas and topographic map of the dam, respectively. Appendix A includes inspection photographs as well as the location of those photographs. Appendix B includes the TCEQ Dam Inspection Form. Directions in the following sections (right and left) are from the perspective of looking downstream.

Photo 1 – Typical Masonry Construction

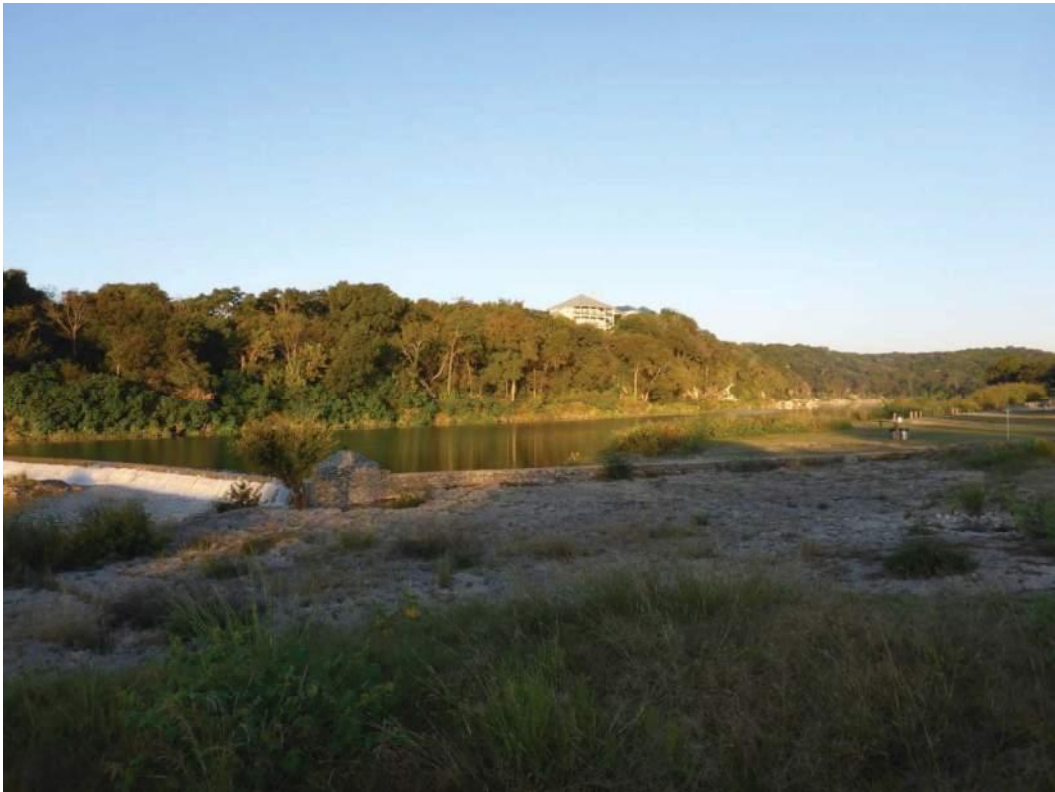
Photo 4 – Left Abutment

The left abutment is comprised of a cylindrical gravity structure that connects to the dam and a limestone mortar wall that extends into the bank (Photo 4). Overall, the left abutment was found to be in fair condition.

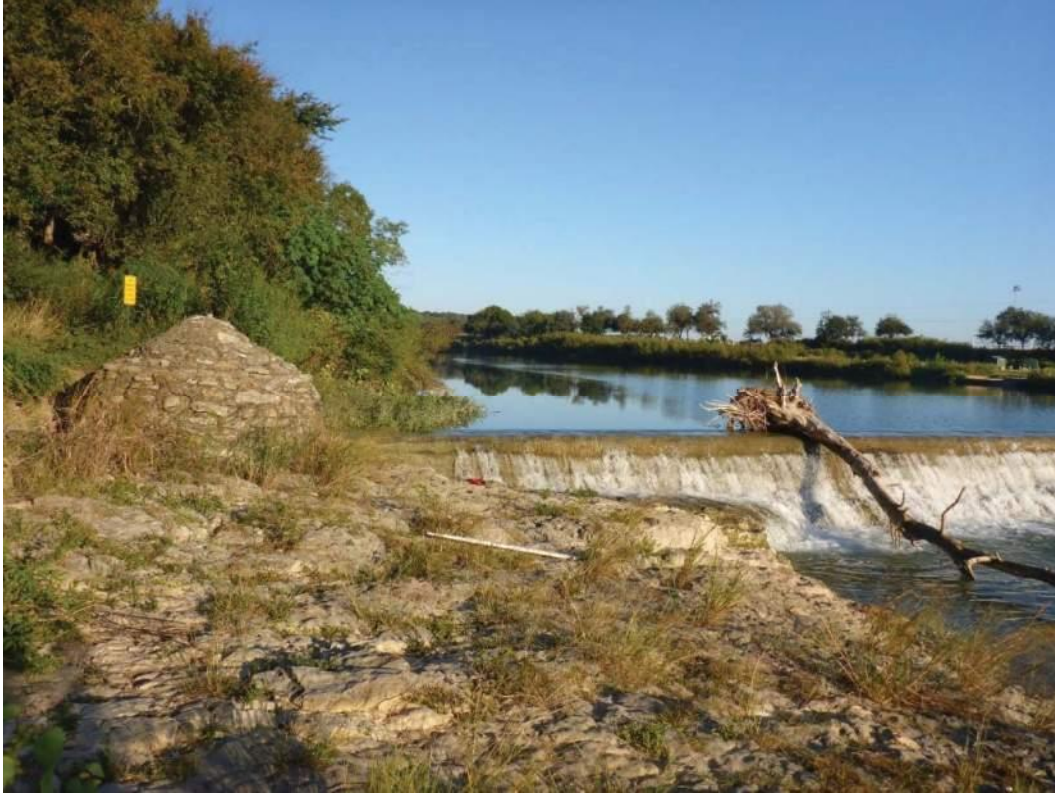
The right abutment is comprised of a cylindrical gravity structure that is founded on the shoreline (Photo 7). Overall, the right abutment was found to be in fair condition.

Photo 7 – Right Abutment Shoreline

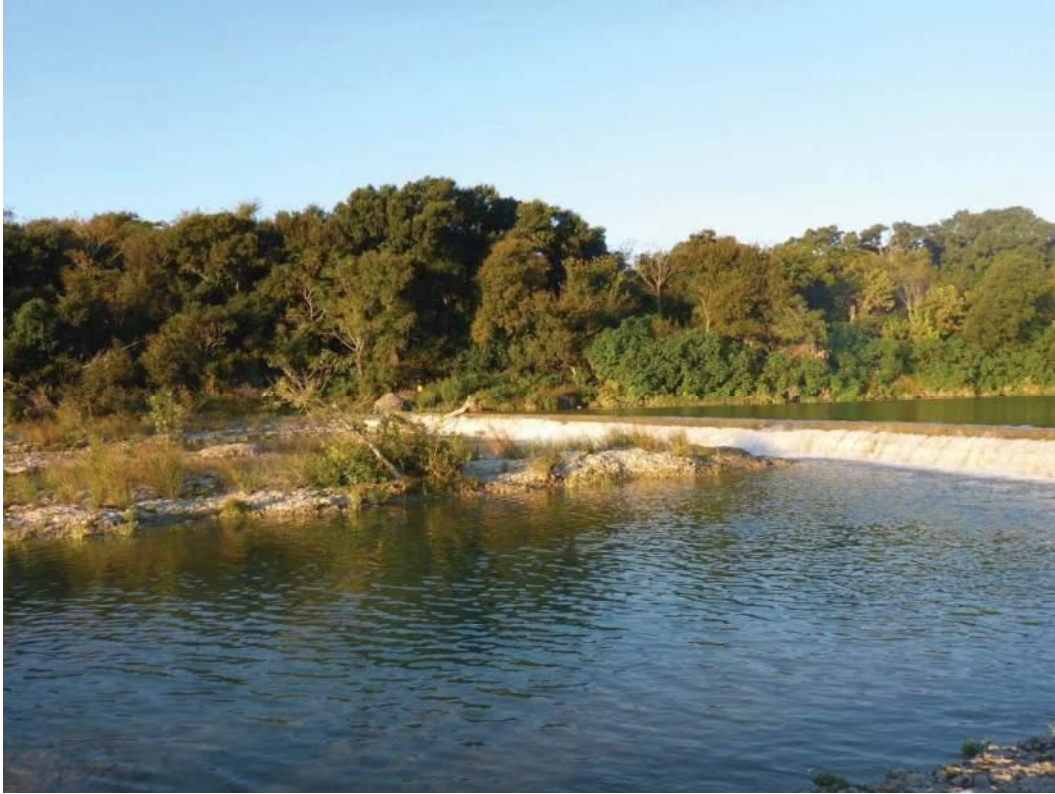
The downstream channel has varying rock topography and a few areas of residual soils and vegetation (Photo 11 & Photo 12).

Photo 11 – Downstream Channel Looking Upstream

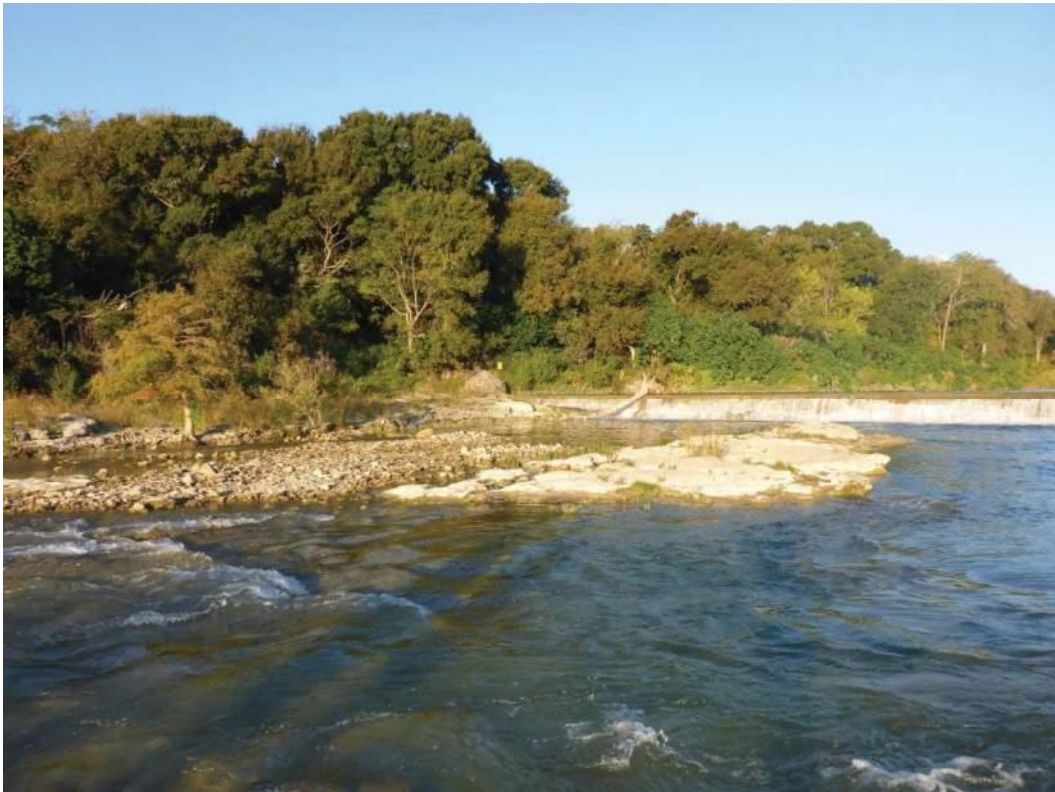
Photo 12 – Downstream Channel Looking Upstream
