# U.S. FISH & WILDLIFE SERVICE

## SAN MARCOS, TEXAS

### CAPE'S DAM-BREACH & CHANNEL RESTORATION

UNITED STATES DEPARTMENT OF THE INTERIOR  
FISH AND WILDLIFE SERVICE  
REGION 6 ENGINEERING - DENVER, COLORADO

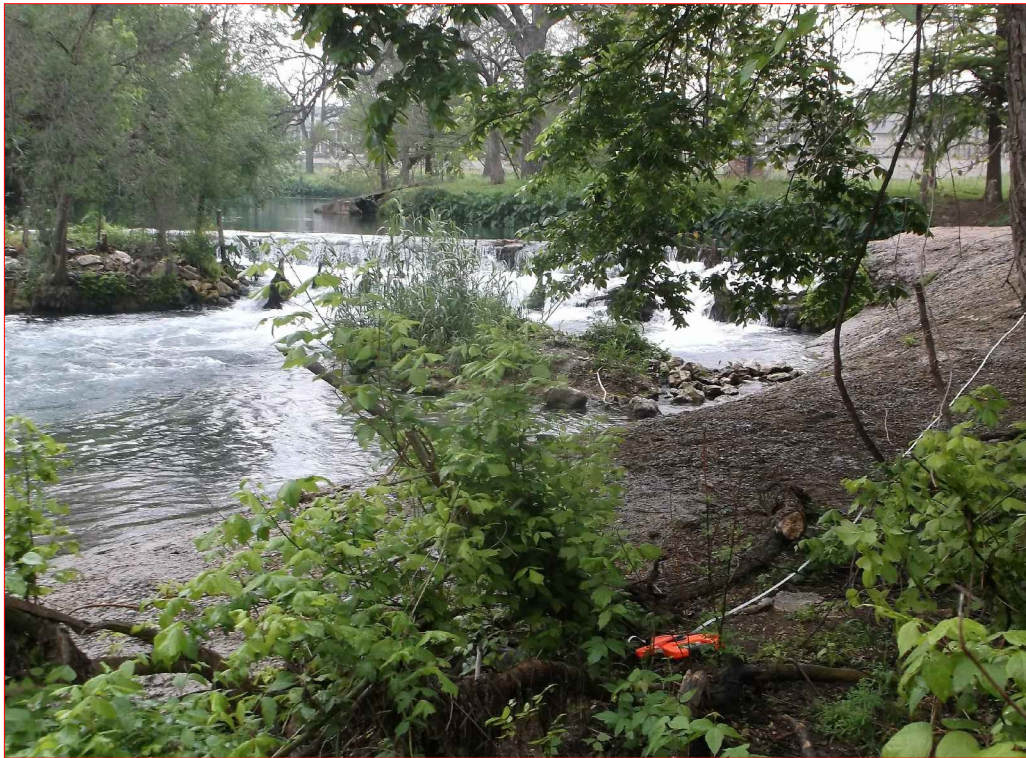
CAPES DAM, ~ 600 CFS, VIEW DOWNSTREAM TO UPSTREAM

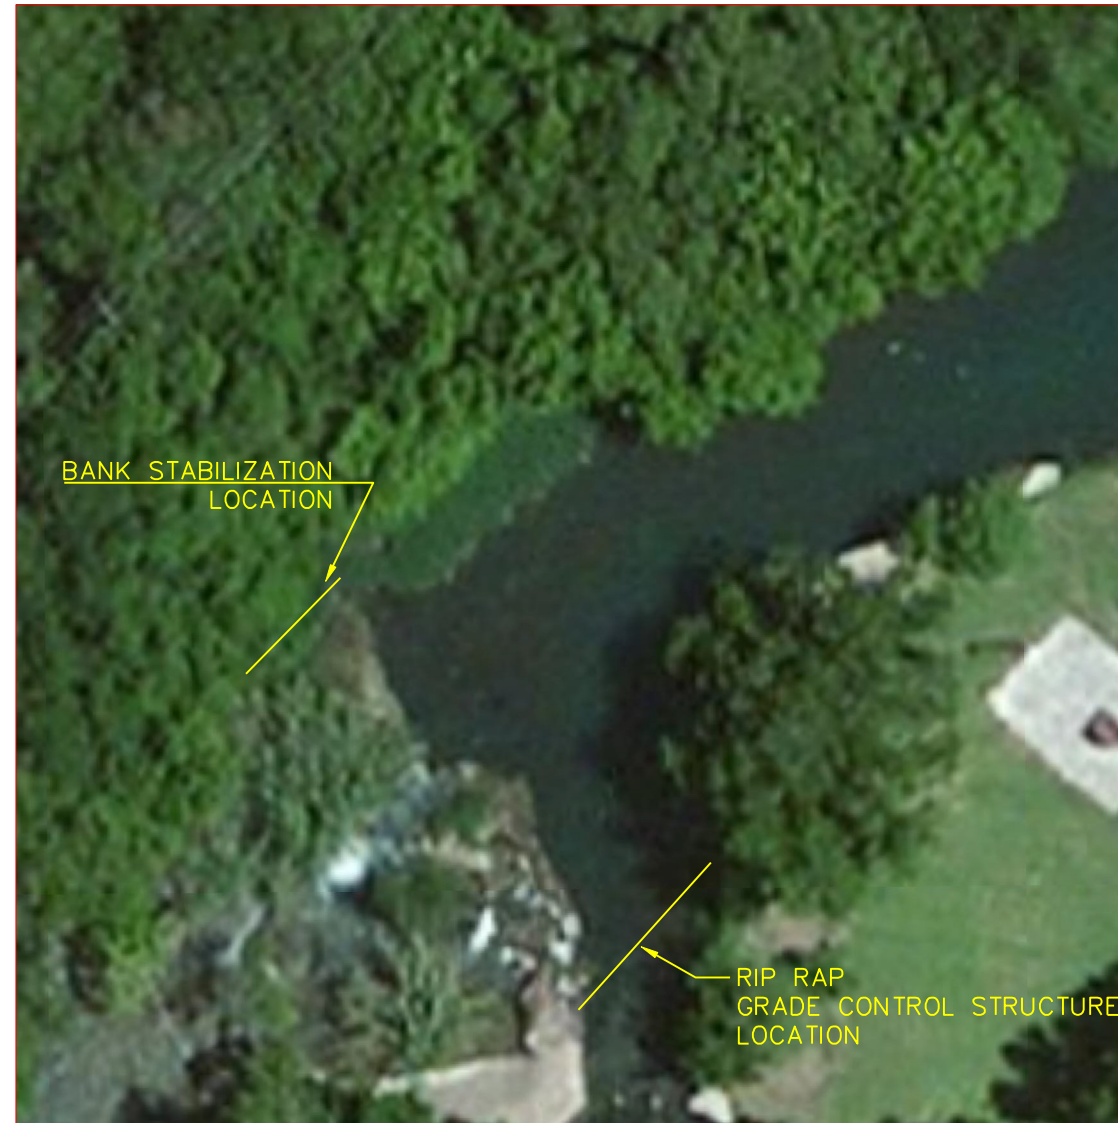
CAPES DAM AREA: EROSION CONTROL INSTALLATION LOCATIONS

RIGHT BANK REFERS TO RIGHT SIDE OF RIVER LOOKING IN THE DOWNSTREAM DIRECTION.

1. COVER SECTION OF RIGHT BANK EXPOSED DURING DAM REMOVAL WITH JUTE FIBER ROLL.
2. JUTE FIBER ROLL MATERIAL EXTENDS Laterally along the bank for ~ 60' AS DEPICTED IN THE ATTACHED PHOTO.

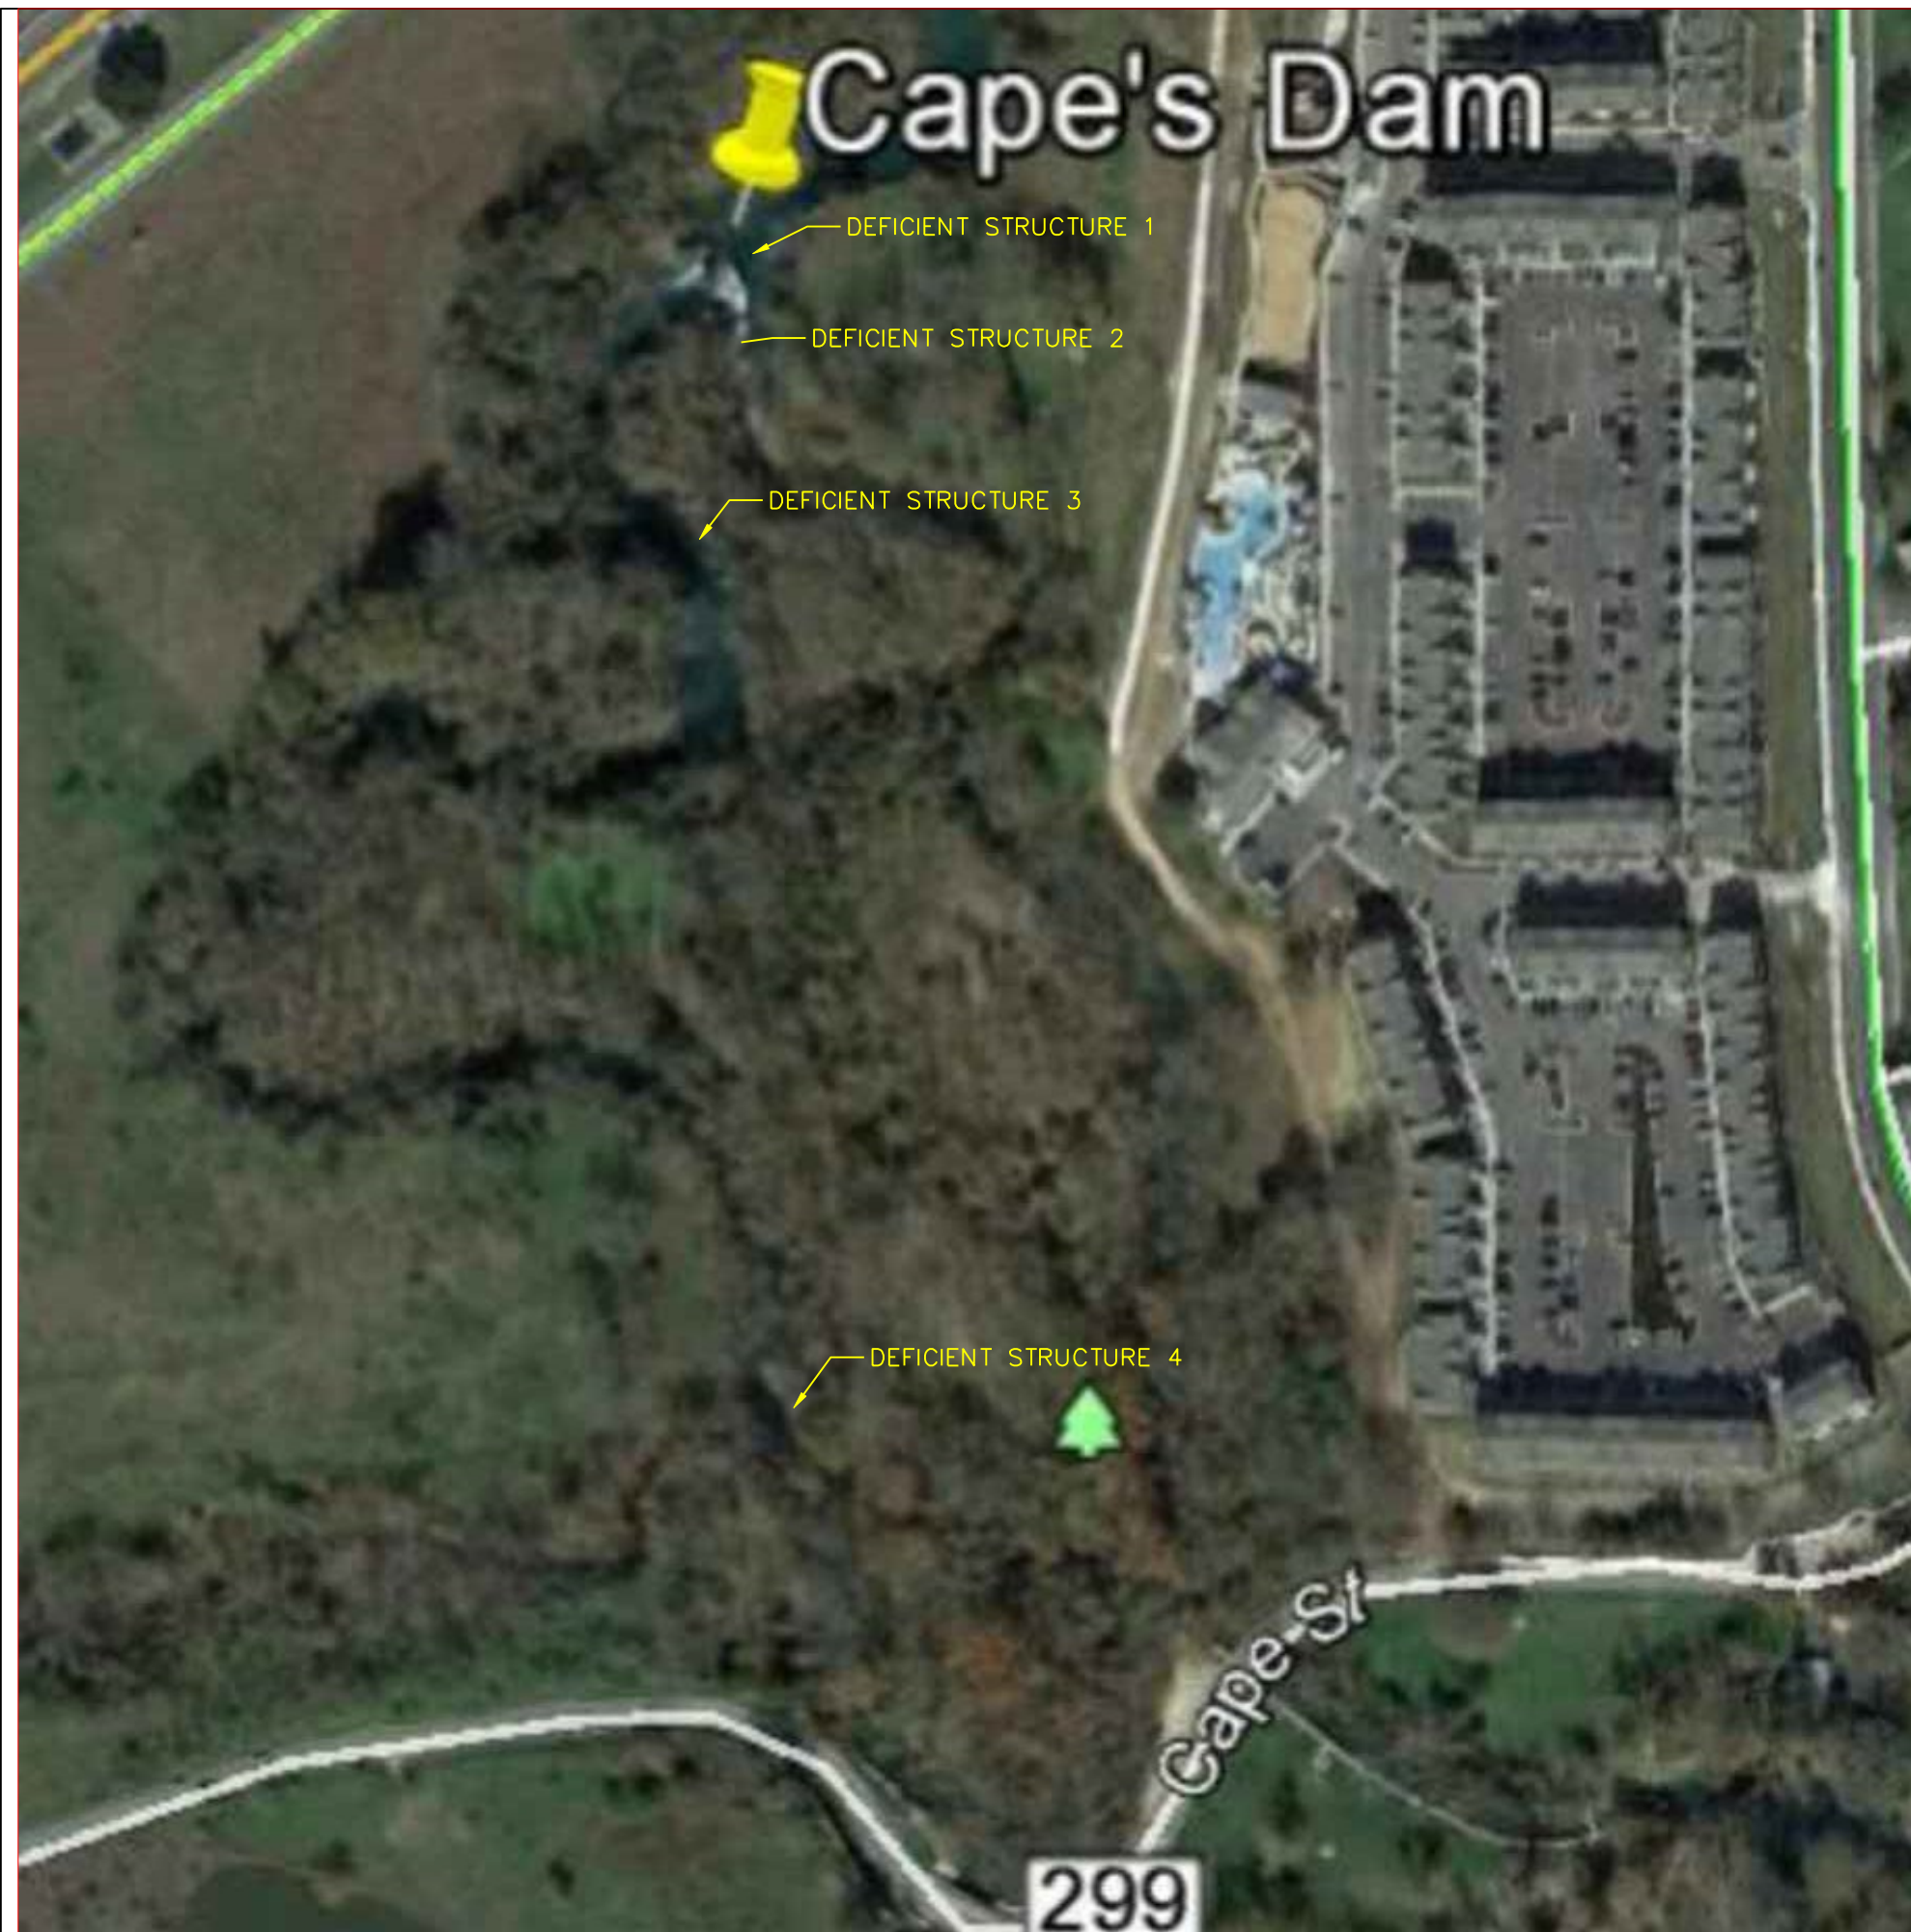
LOCATIONS DEPICTED ON IMAGE ARE APPROXIMATE. SEE GPS COORDINATES AND PICTURES ON SHEET 9 FOR DETAILED LOCATIONS.

1. LOCATION: -97.931534; 29.872978.
2. STRUCTURE IS A CONCRETE-SLAB COMPROMISED BY BANK EROSION.
3. NO INFORMATION EXISTS ON THE SLABS CONDITION OR EMBEDMENT DEPTH.
4. THE CONCRETE-SLAB SHALL BE BROKEN INTO PIECES NO LARGER THAN 8 CUBIC FEET AND EXPORTED OFF SITE.

1. LOCATION: -97.931794; 29.872696.
2. STRUCTURE IS A CONCRETE-SLAB COMPROMISED BY BANK EROSION.
3. NO INFORMATION EXISTS ON THE SLABS CONDITION OR EMBEDMENT DEPTH.
4. THE CONCRETE-SLAB SHALL BE BROKEN INTO PIECES NO LARGER THAN 8 CUBIC FEET AND EXPORTED OFF SITE.

1. LOCATION: -97.931934; 29.870159.
2. STRUCTURES INCLUDE A CONCRETE BRIDGE AND CONCRETE RUBBLE PLACED ON THE BANK FOR EROSION PROTECTION.
3. NO INFORMATION EXISTS ON THE SLABS CONDITION OR EMBEDMENT DEPTH.
4. THE CONCRETE-SLAB SHALL BE BROKEN INTO PIECES NO LARGER THAN 8 CUBIC FEET AND EXPORTED OFF SITE.

1. LOCATION: -97.931456; 29.869921.
2. STRUCTURE INCLUDES A DIVERSION STRUCTURE CONSTRUCTED OF CONCRETE.
3. NO INFORMATION EXISTS ON THE STRUCTURES CONDITION OR EMBEDMENT DEPTH.
4. THE STRUCTURE SHALL BE BROKEN INTO PIECES NO LARGER THAN 8 CUBIC FEET AND TRANSPORTED OFF SITE.

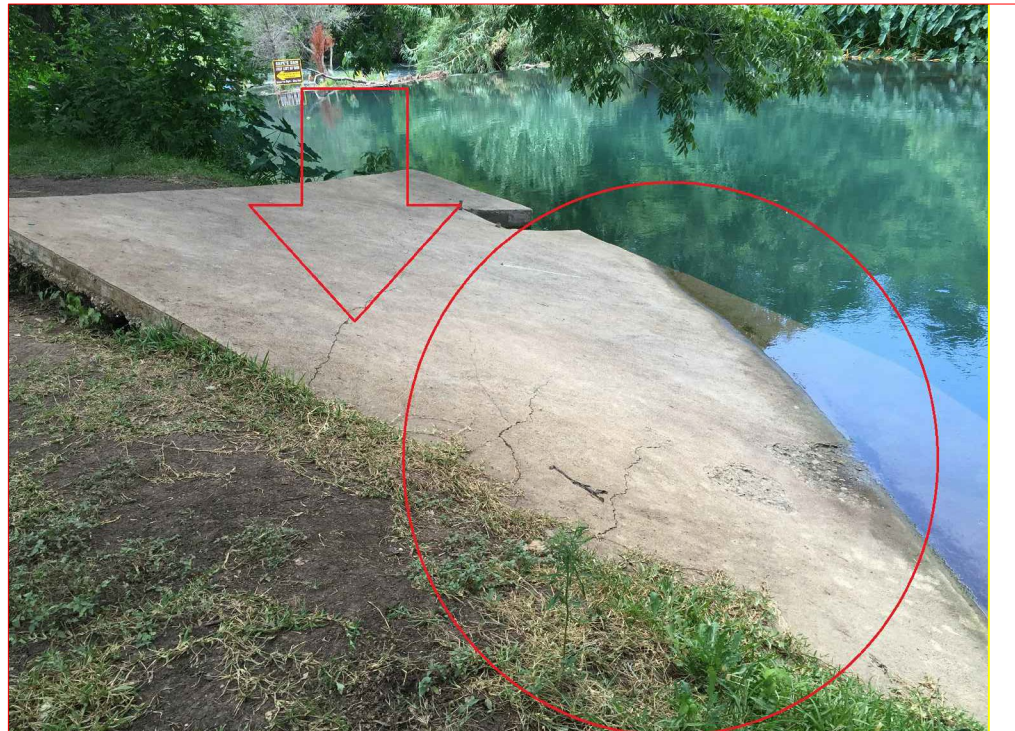
DEFICIENT STRUCTURE 1. CONCRETE BANK-STABILIZAION STRUCTURE

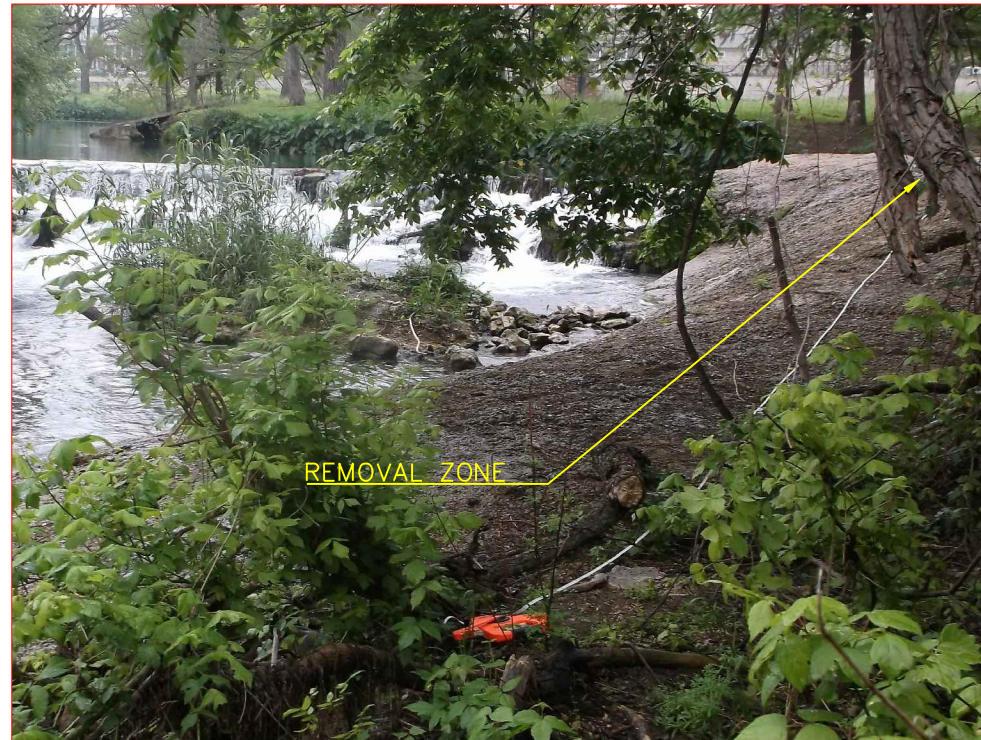
DEFICIENT STRUCTURE 2. CONCRETE BANK-STABILIZATION STRUCTURE

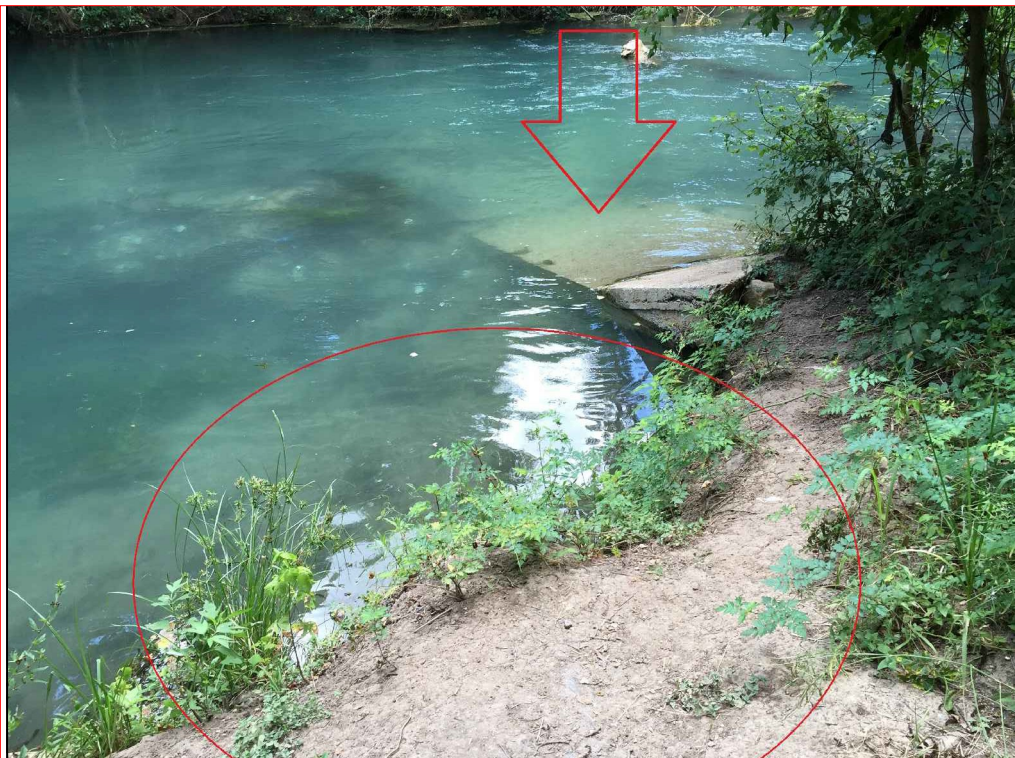
DEFICIENT STRUCTURE 3. COMPROMISED BRIDGE & BANK-STABILIZATION

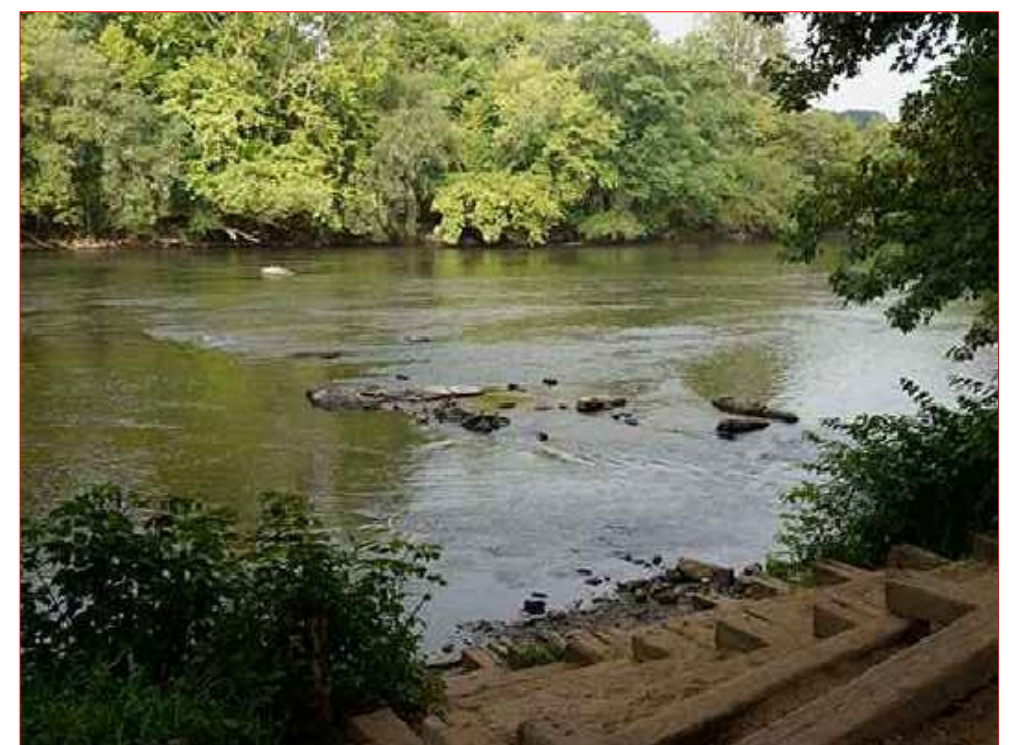
NEW ACCESS POINT DESIGN (TYPICAL)

LOCATIONS DEPICTED ON IMAGE ARE APPROXIMATE. SEE GPS COORDINATES AND PICTURES ON SHEET 11 FOR DETAILED LOCATIONS. ACCESS POINT DEVELOPMENT STYLES AND METHODS DEPICTED ON SHEET 11 ARE TYPICAL. ACCESS POINTS WILL BE CONSTRUCTED AS DETERMINED BY THE CITY OF SAN MARCOS.
